**PIMA DEPARTMENT OF ENVIRONMENTAL QUALITY
AIR PROGRAM**

OPPORTUNITY TO CORRECT - TRACKING # 0910-122

December 4, 2009

Complaint Investigation Report

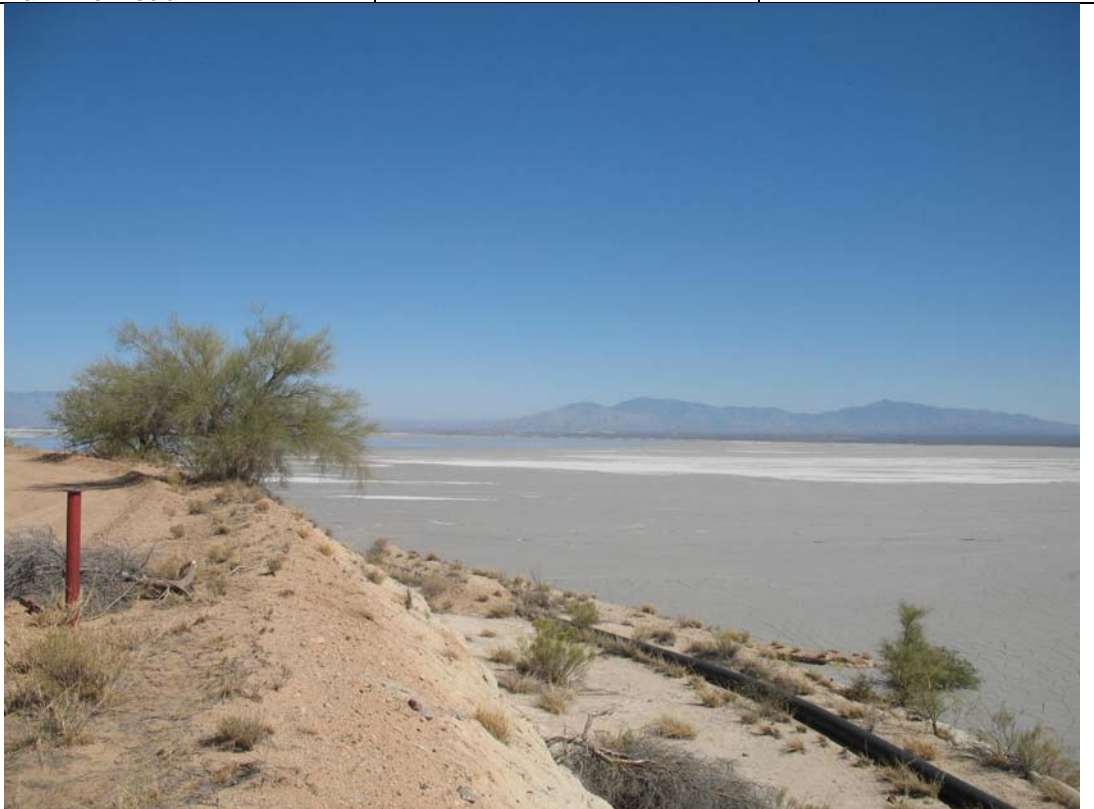
Photo No. 1
Date: 10/21/2009
Photo Description: View of the top surface of tailings dam #7 (as viewed from Point T-5 of the Visual Observation Plan). The dam is in use and wet and moist over most of the surface area.

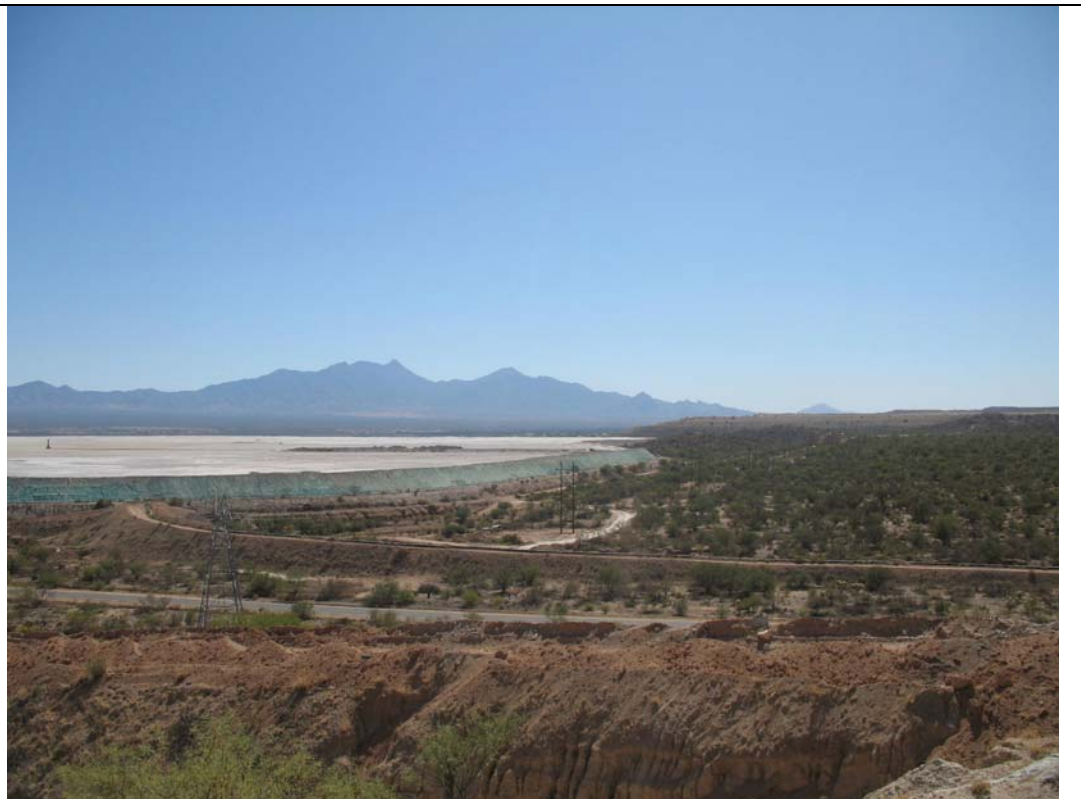
Photo No. 2
Date: 10/21/2009
Photo Description: View of the tailings dam #8. A new berm has been built on the west and north faces. The slopes are colored blue from the polymer stabilizer applied to the surface.

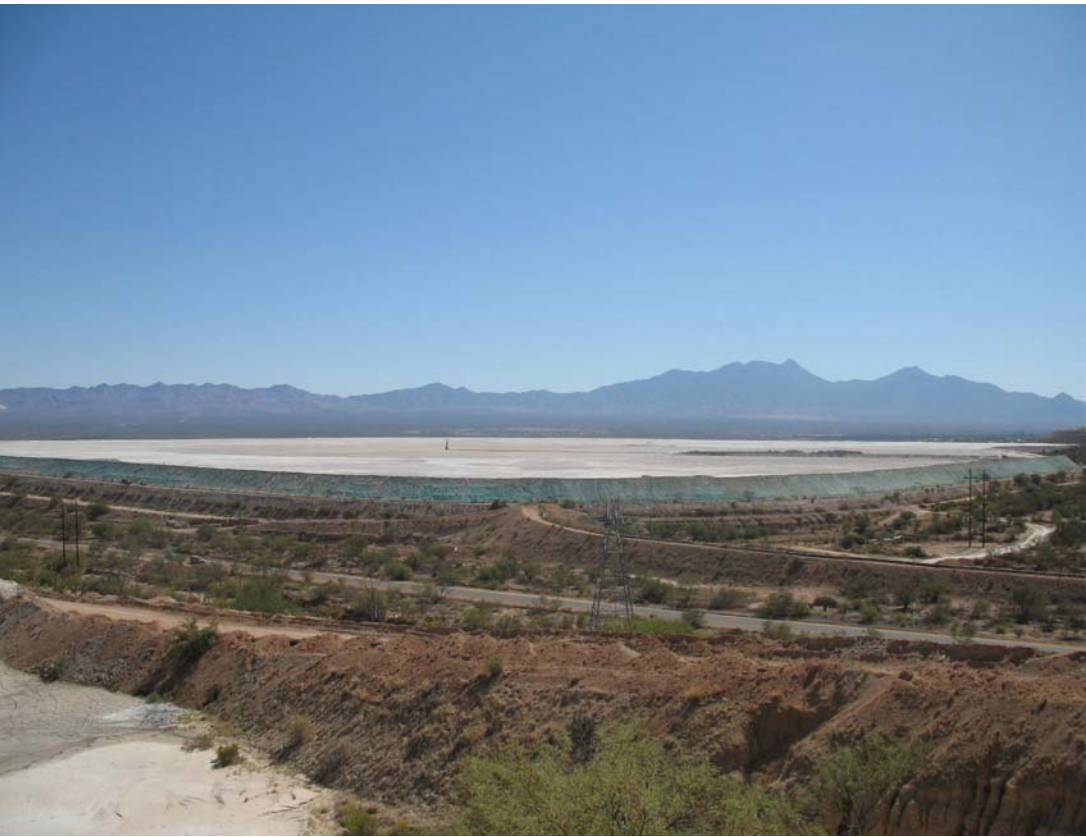
Photo No. 3

Date: 10/21/2009	
Photo Description: View of the tailings dam #8. A new berm has been built on the west and north faces. The outer sides of the slopes are colored blue from the polymer stabilizer applied to the surface.

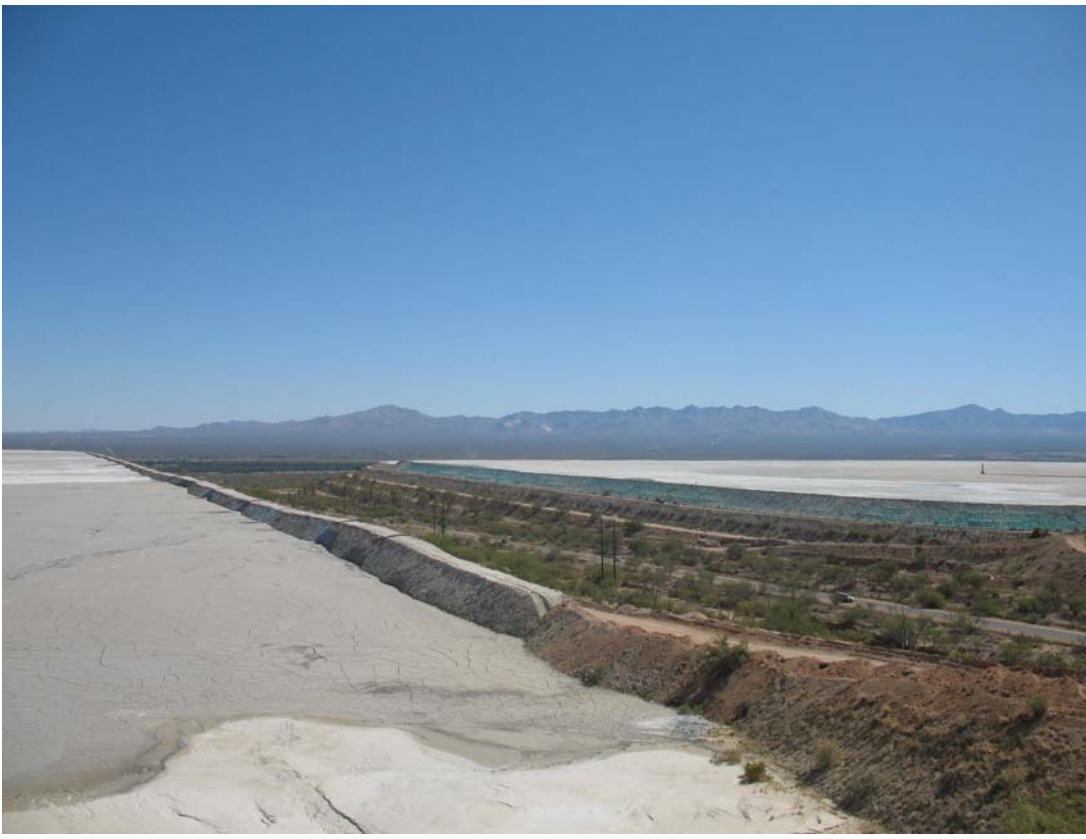
Photo No. 4

Date: 10/21/2009	
Photo Description: View of the tailings dam #8. A new berm has been built on the west and north faces. The outer sides of the slopes are colored blue from the polymer stabilizer applied to the surface.

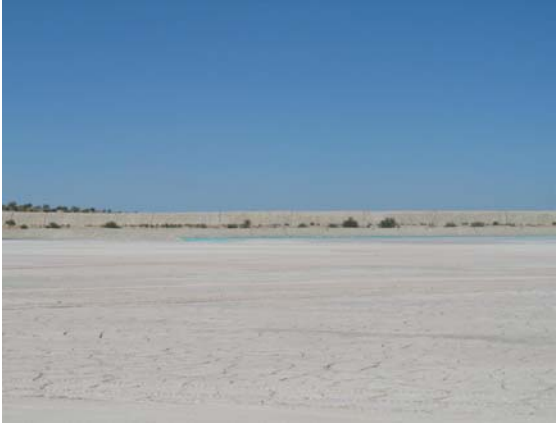
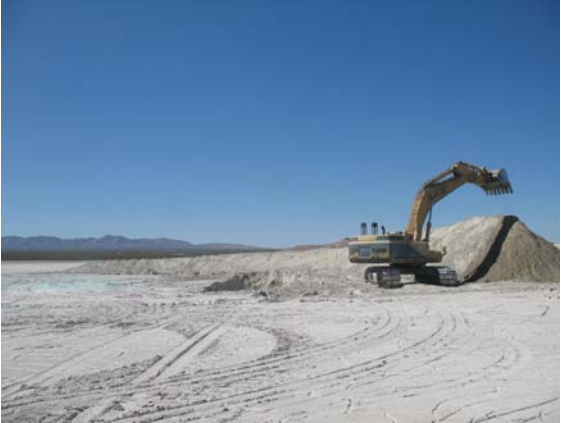
Photo No. 7 a, b	
Date: 10/21/2009	
Photo Description: View of polymer stabilized areas on inner base of the north berm (blue). Bucket excavator at the present point of berm building.	<p data-bbox="690 583 706 604">a</p>

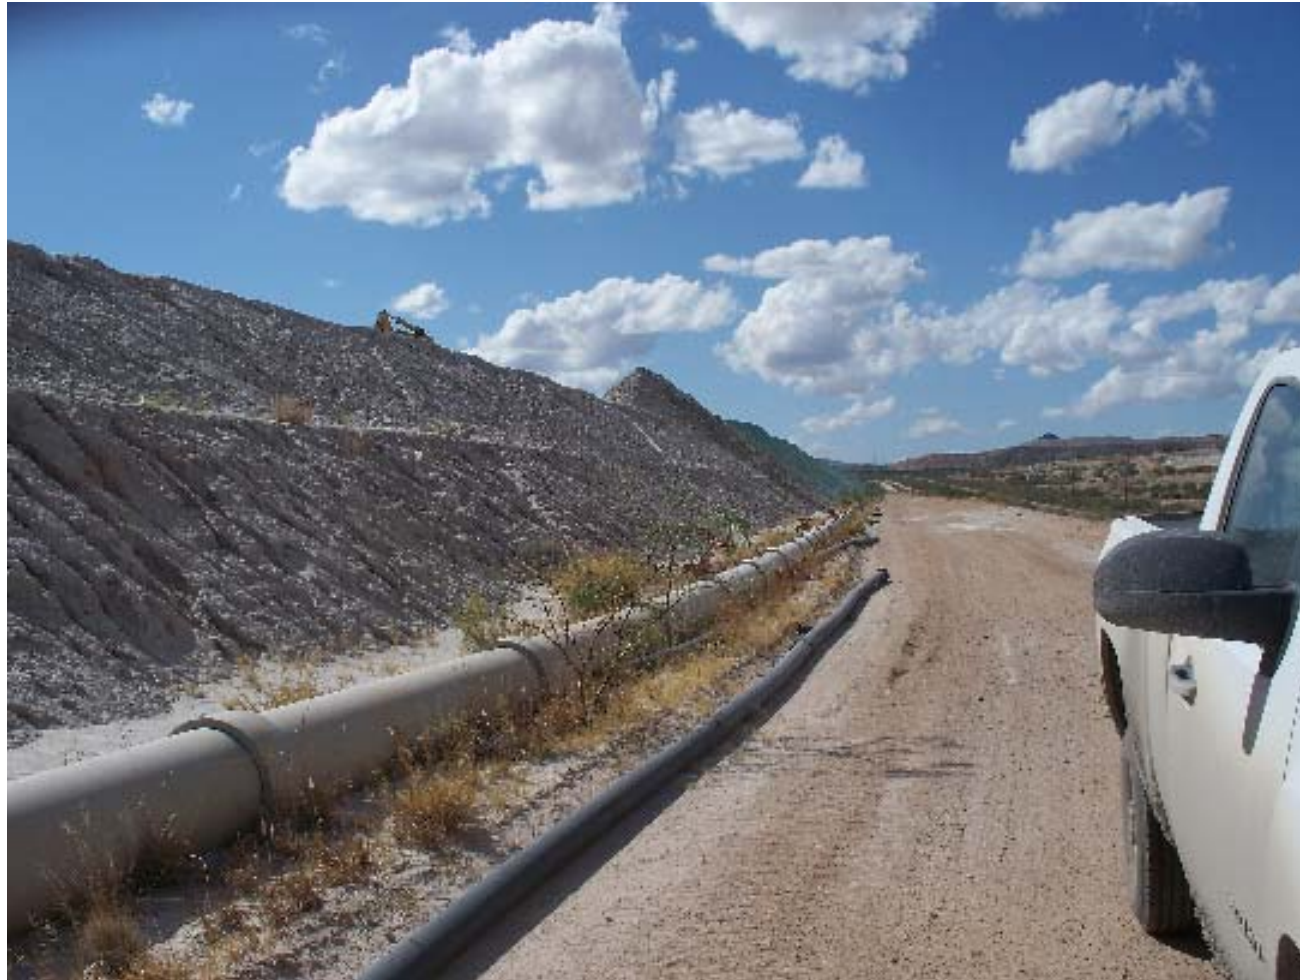
Berm Building Area. North side of Tailing # 8.
Berm building stopped

- Berm building activities on Tailing # 8 were immediately stopped.
- Mission Mine General manager was updated on the windy situation and got his approval for overtime labor to ensure that the sources generating dust within Tailing # 8 were properly addressed
- Immediately mobilized two dedicated water trucks to the area.
 - A total of 9 totes of polymer were applied in the area for a total usage of 22500 gallons
 - Additionally, 24000 gallons of water were sprayed to suppress dust conditions

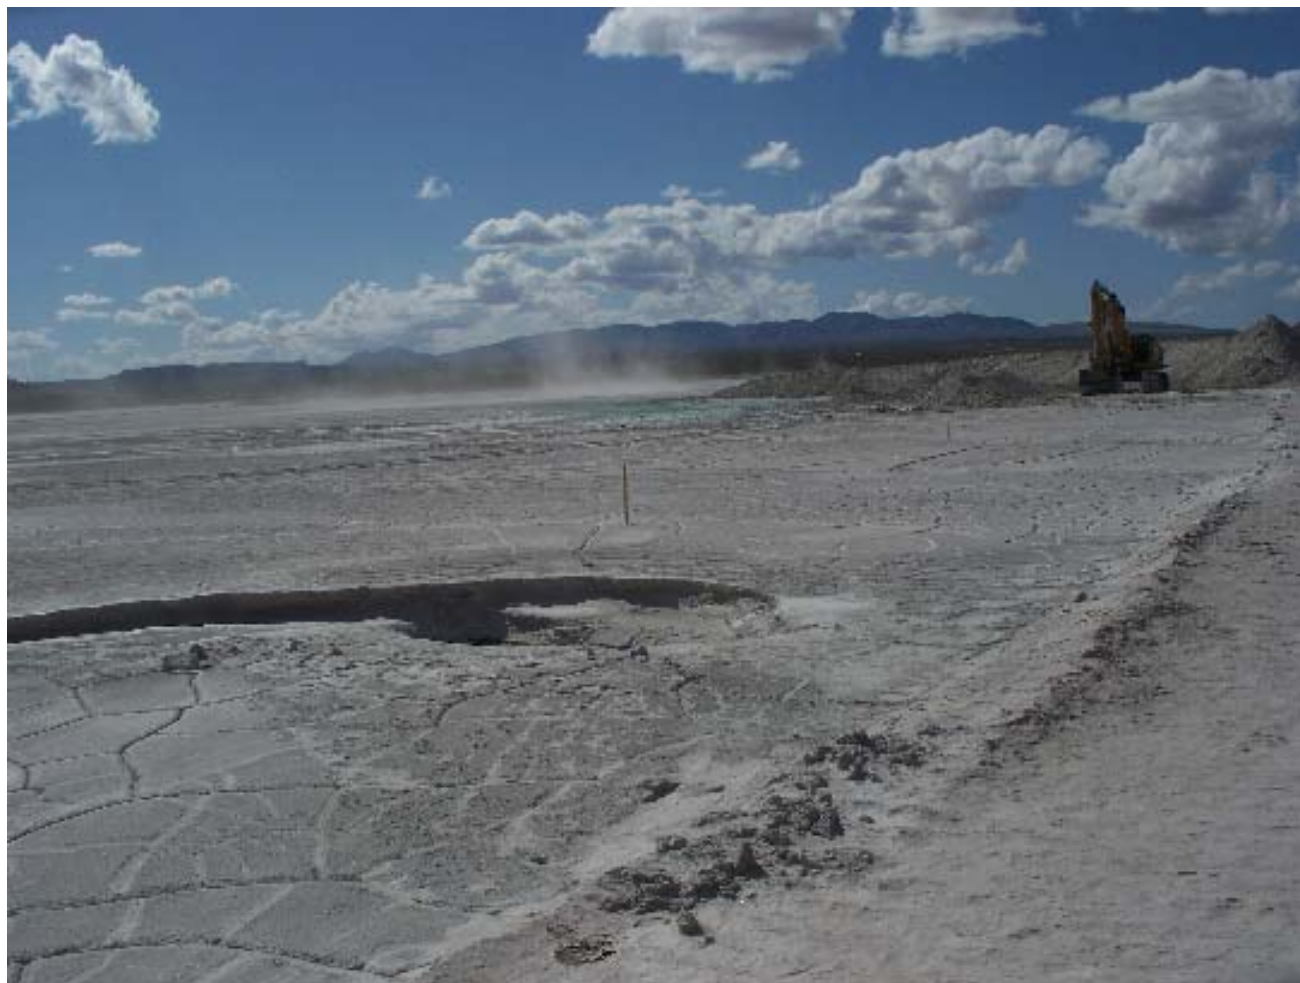
On top of Tailing # 8. looking West.
Dusty conditions generated by the water truck

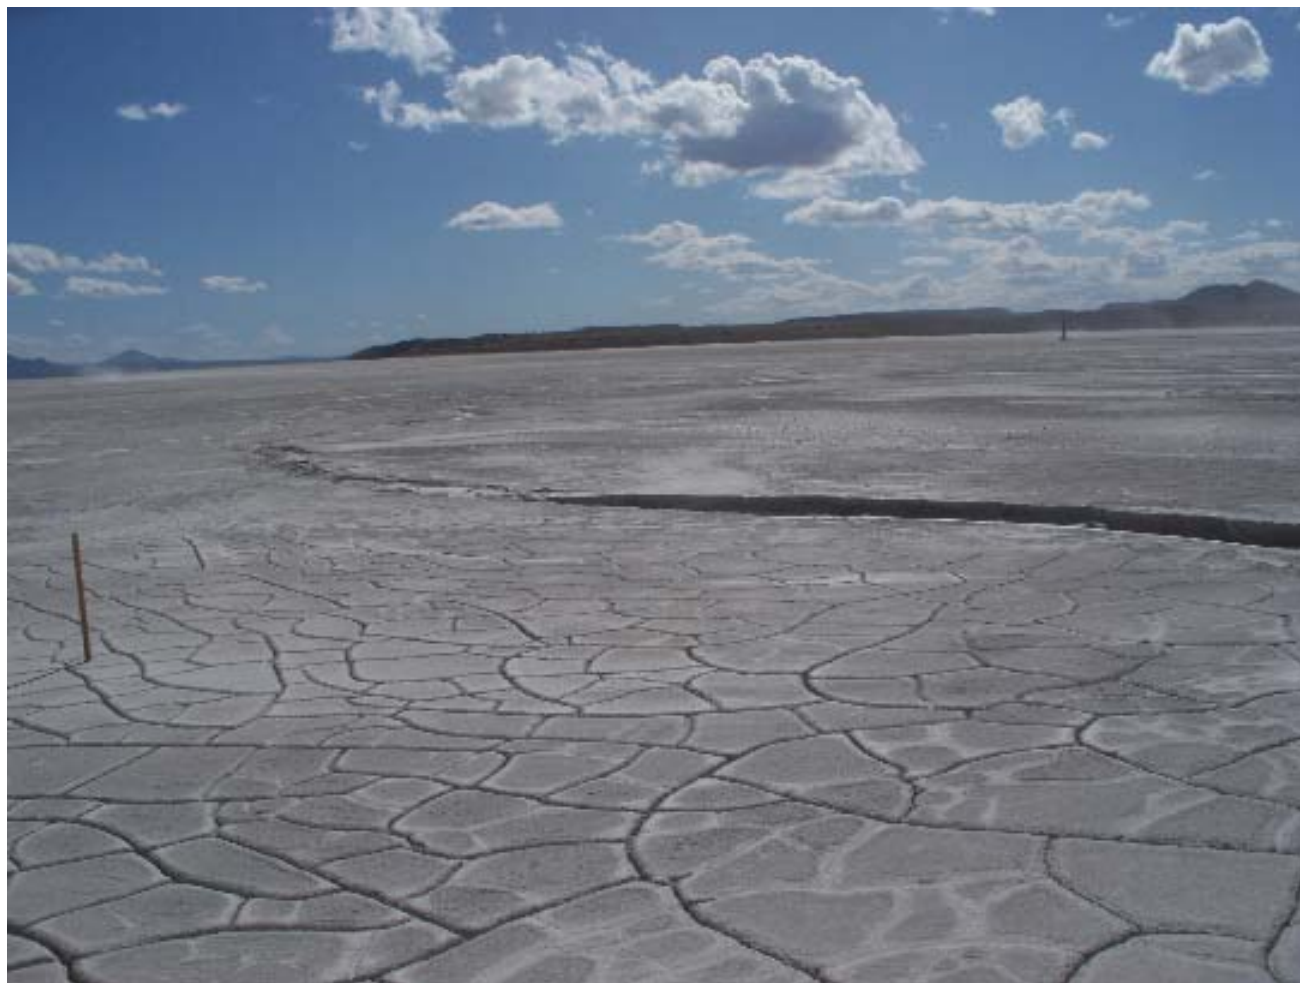
On top of Tailing # 8. Looking SW

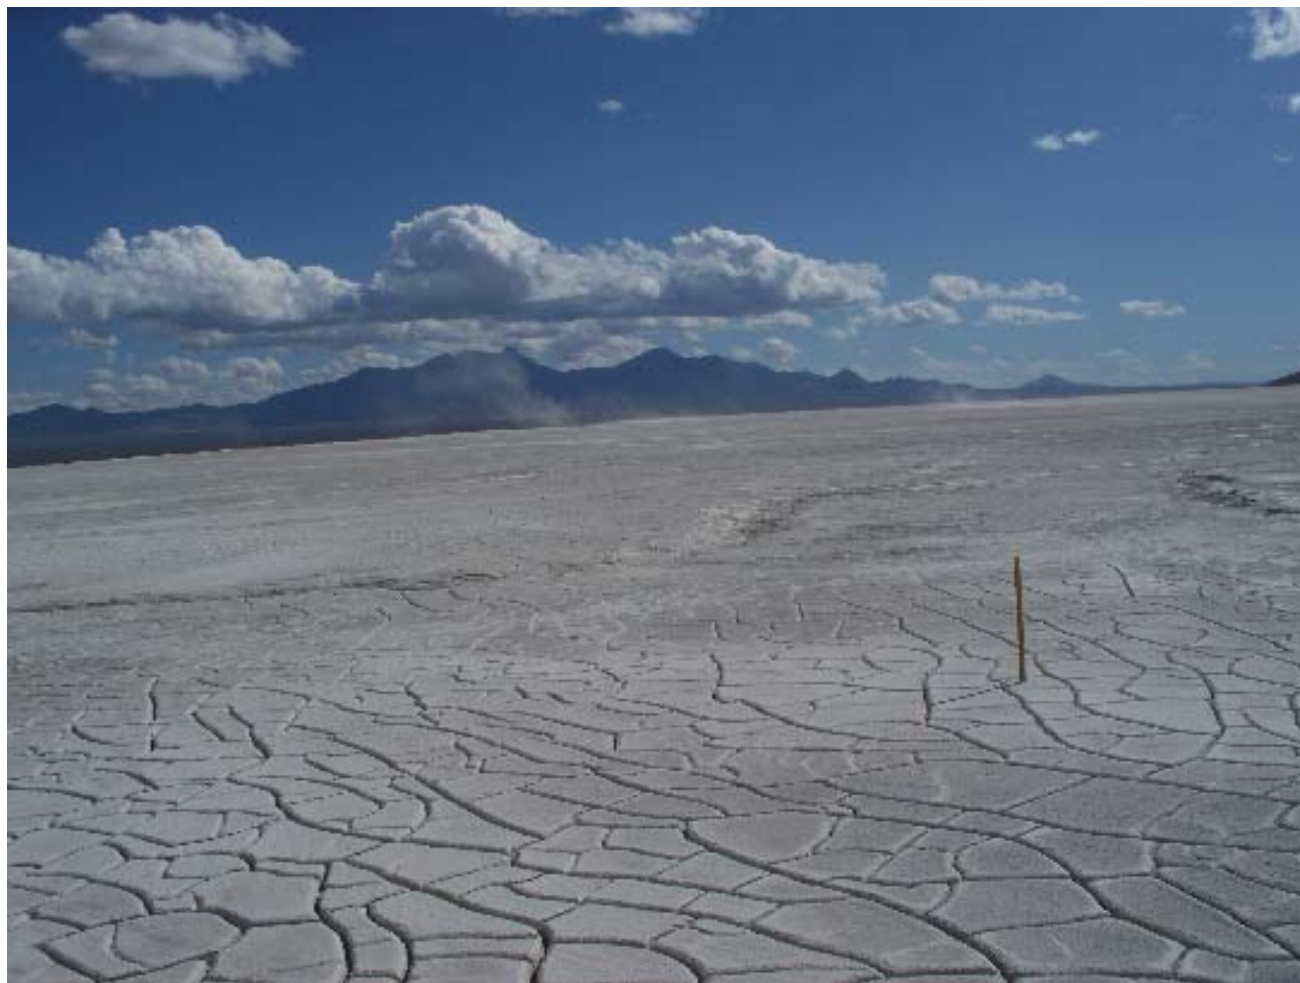
On top of Tailing # 8. Looking SW

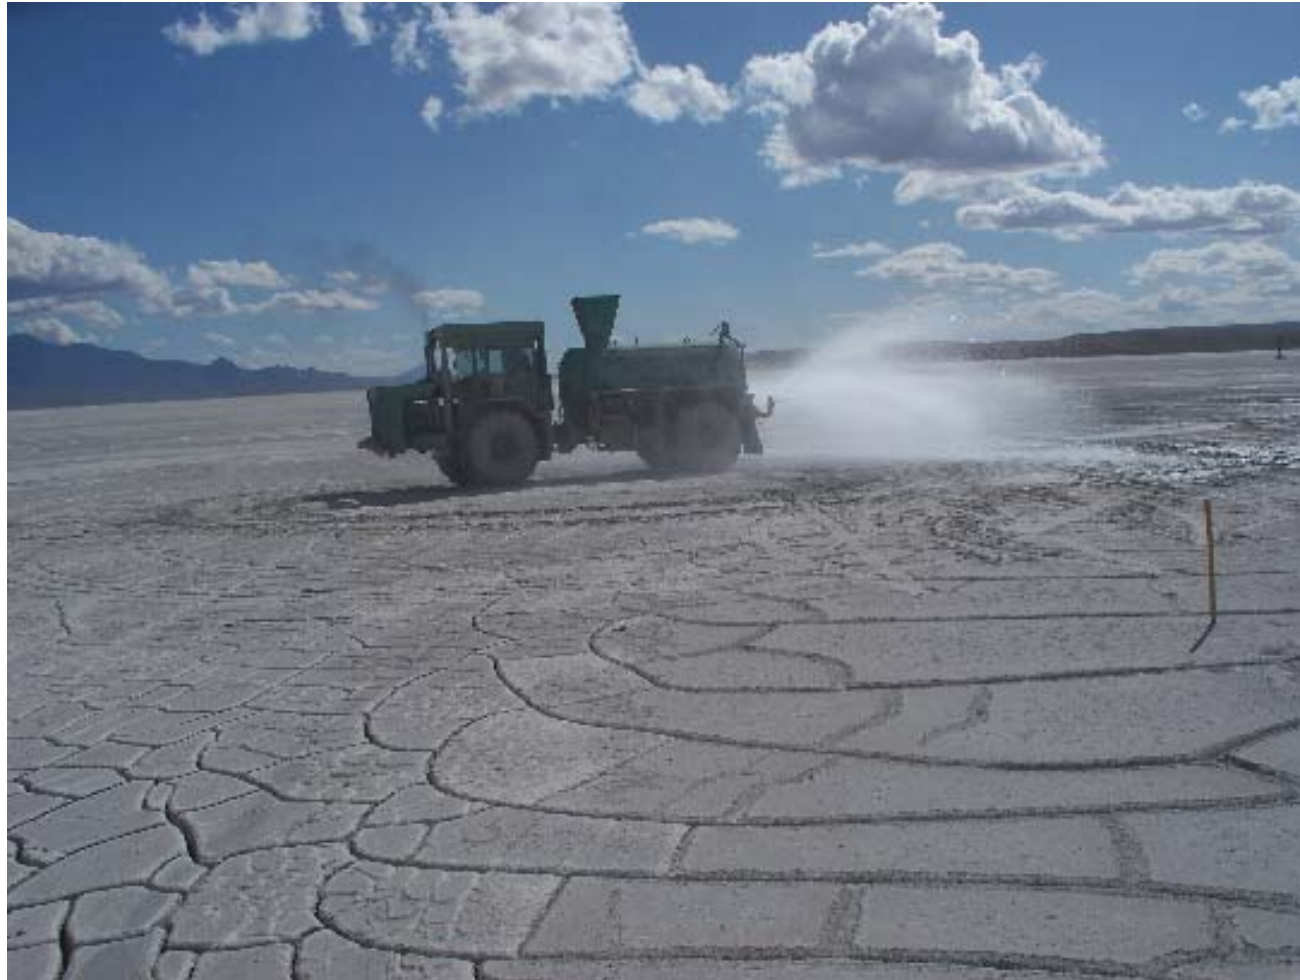
On top of Tailing # 8. Water being applied to areas suspect to generate dust

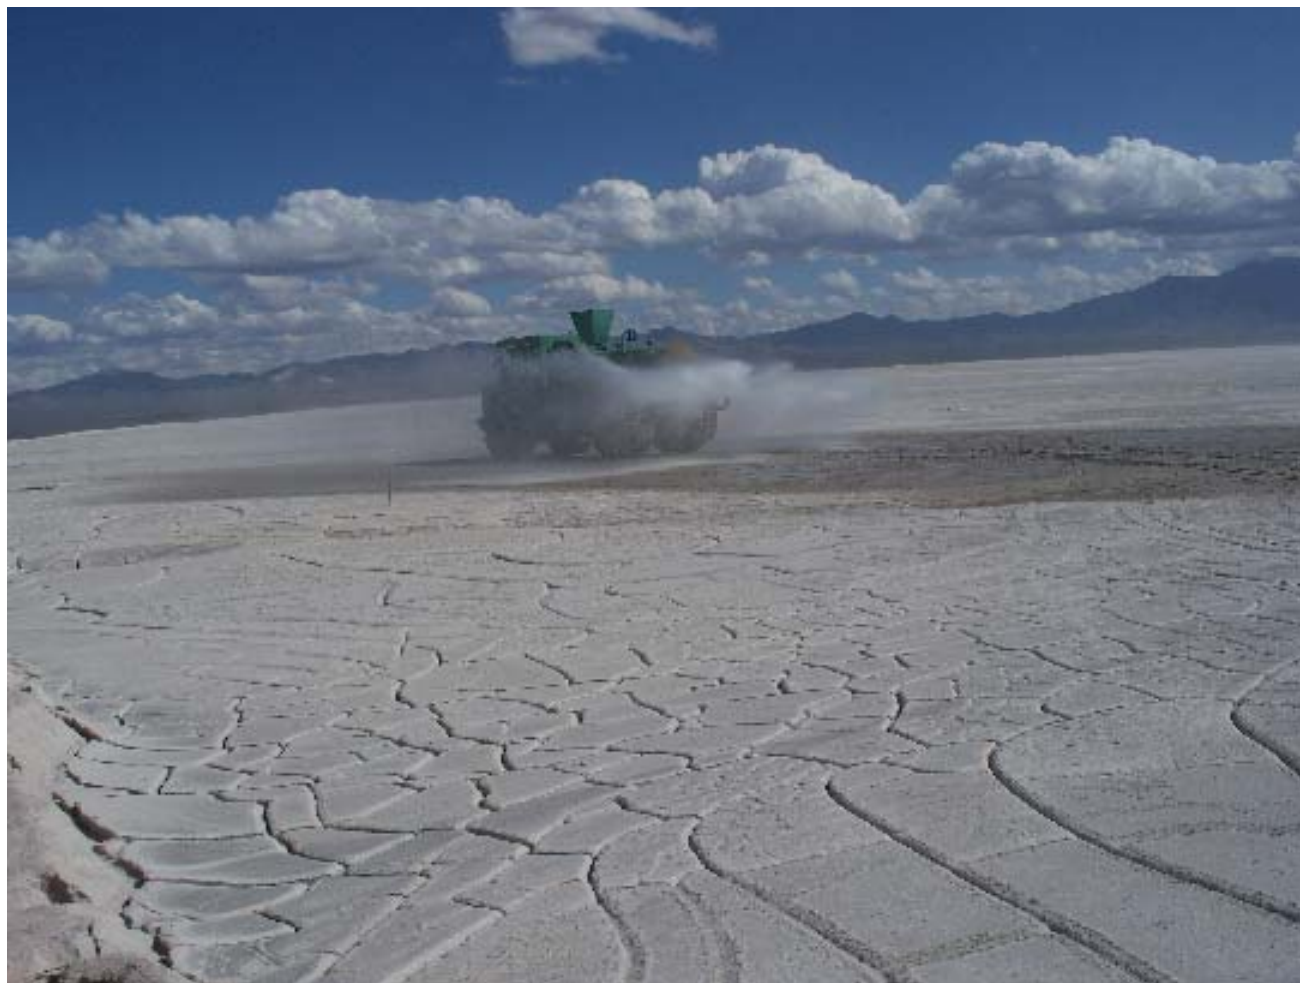
On top of Tailing # 8. Water being applied to areas suspect to generate dust

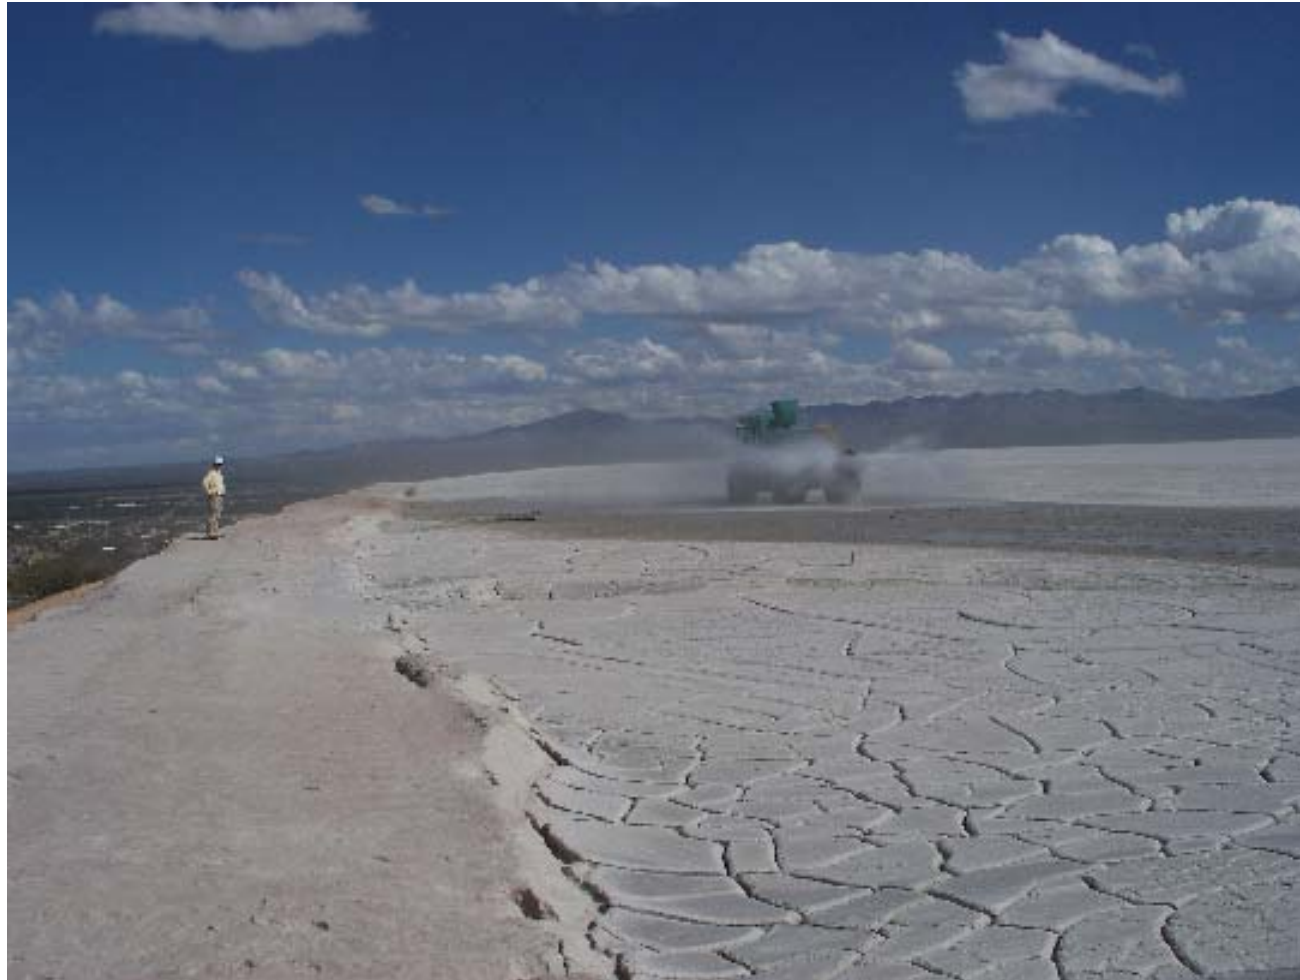
On top of Tailing # 8. Water being applied to areas suspect to generate dust

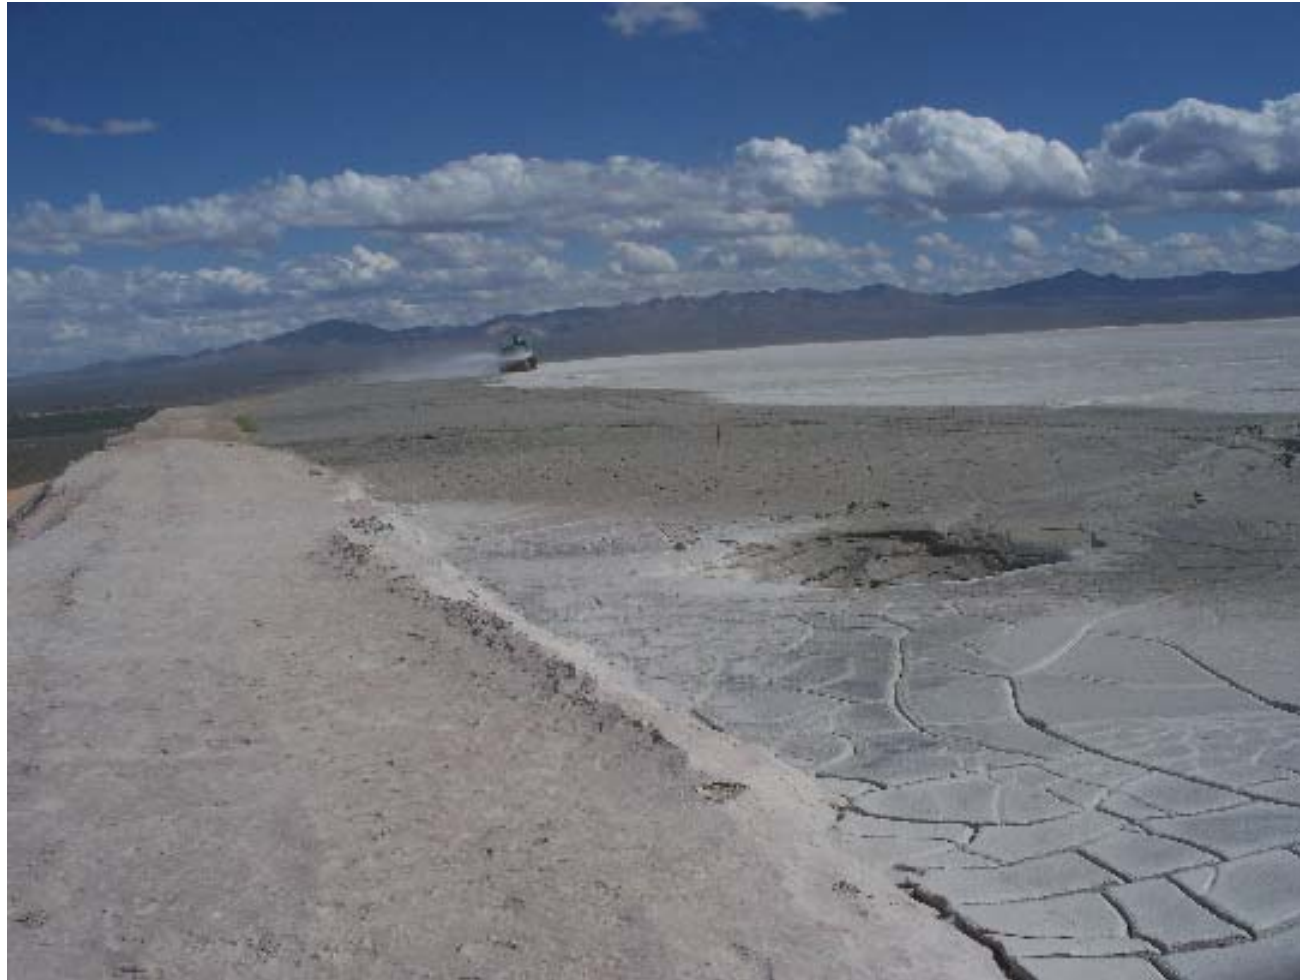
On top of Tailing # 8. Water being applied to areas suspect to generate dust

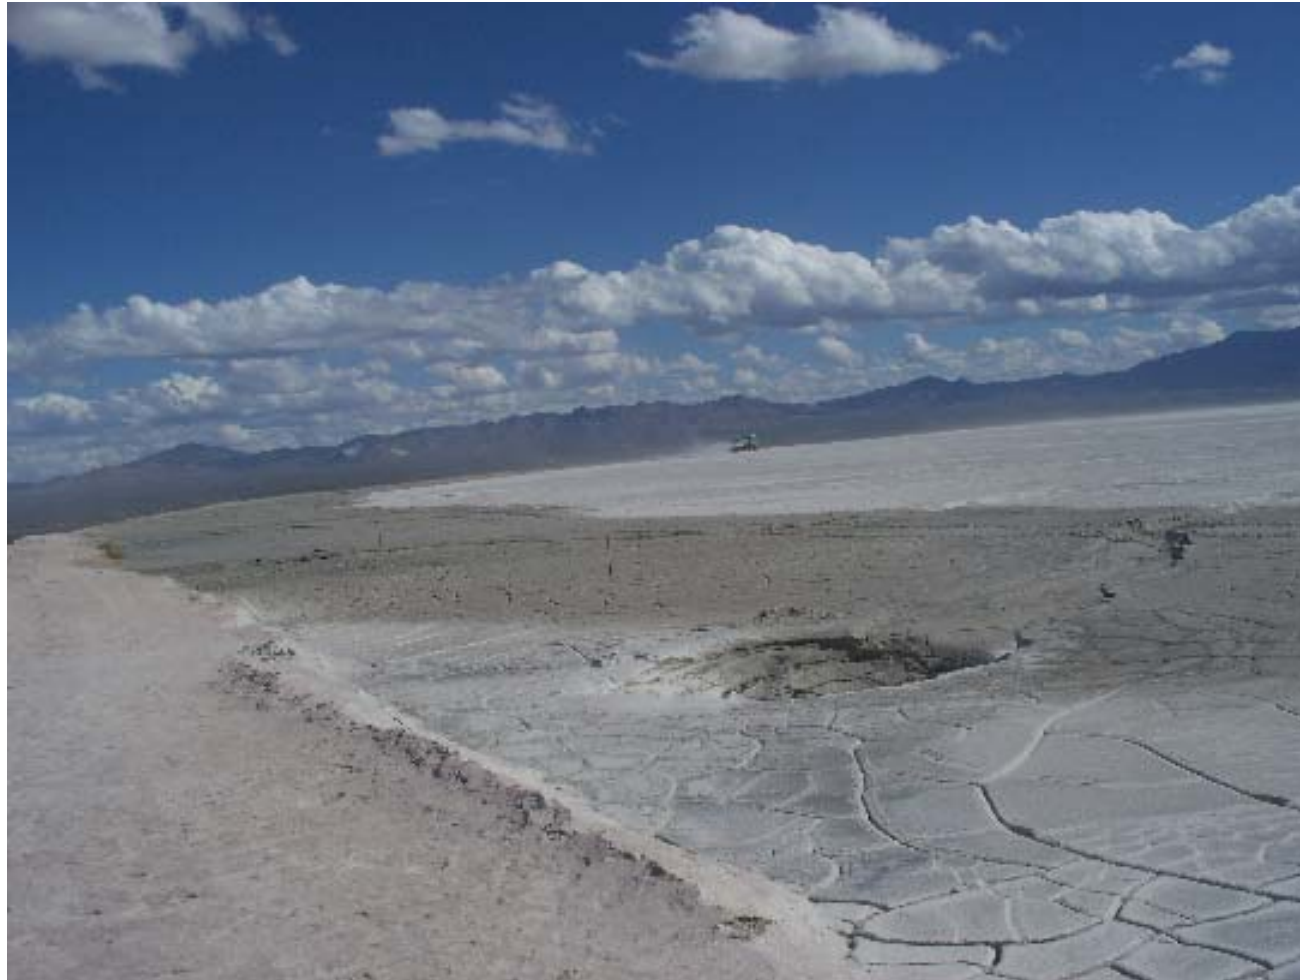
On top of Tailing # 8. Water being applied to areas suspect to generate dust

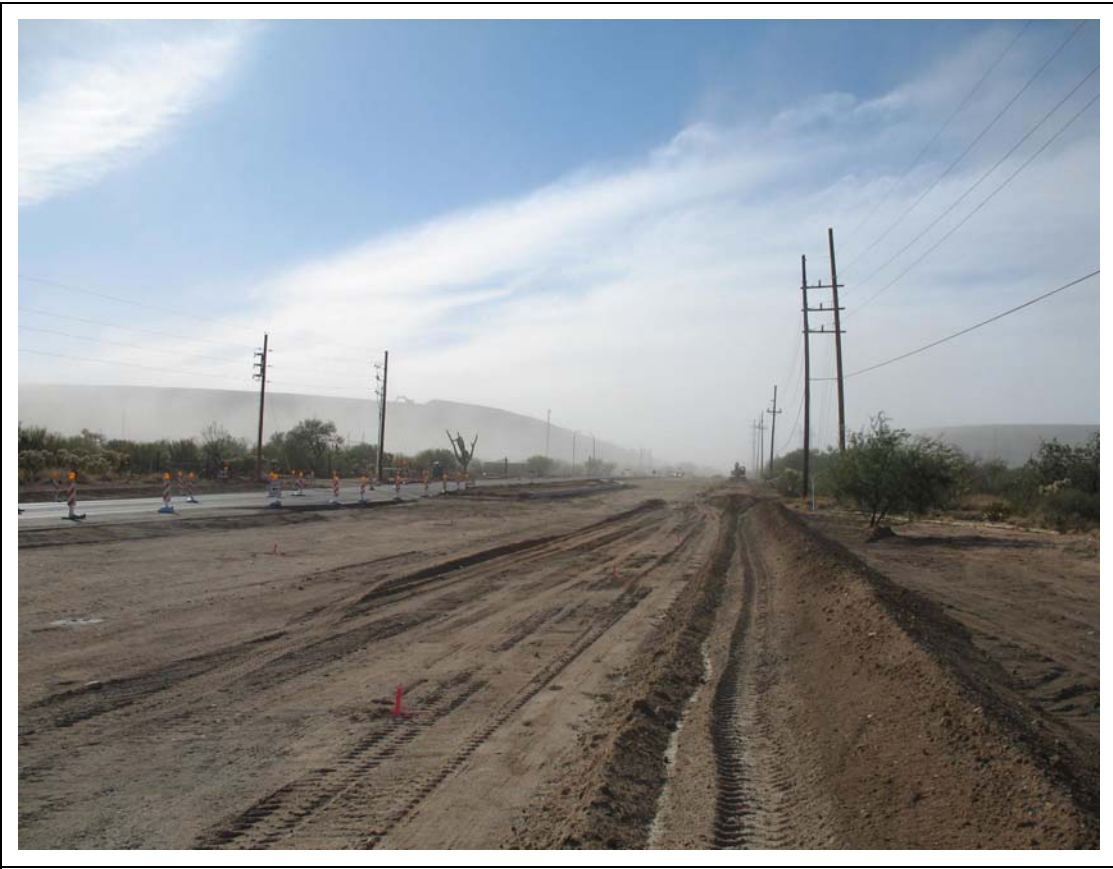
<p>Photo No. 4</p>

Upon arriving at the complaint location the inspector observed fugitive particulate emissions from tailings dam #8 (Attachment 1, Photo No's 2-4). The inspector observed that the excavator on top of the tailings dam was not operating. Between 2:58 pm and 3:00 pm the inspector observed fugitive particulate matter emissions along the edge of the east slope of tailings dam #8 that appeared to be swept by the winds from the top of the dam across Helmet Peak Road. The inspector's viewing position was not at a proper angle in relation to the sun location to perform a Method 9 Visible Emission evaluation (VE). The inspector measured the windspeed to be 12 mph average, 17 mph maximum, and direction from the southwest at the time of the observation.

<p>Date: 10/27/2009</p>	
<p>Photo Description:</p> <p>View fugitive particulate matter emissions from tailings tam #8 between 2:58 pm and 3:00 pm at the intersection of LaCanada Drive and Helmet Peak Road.</p> <p>Windspeed and direction was measured to be 12 mph average, 17 mph maximum at the time and location of the observation from the south/southwest.</p>

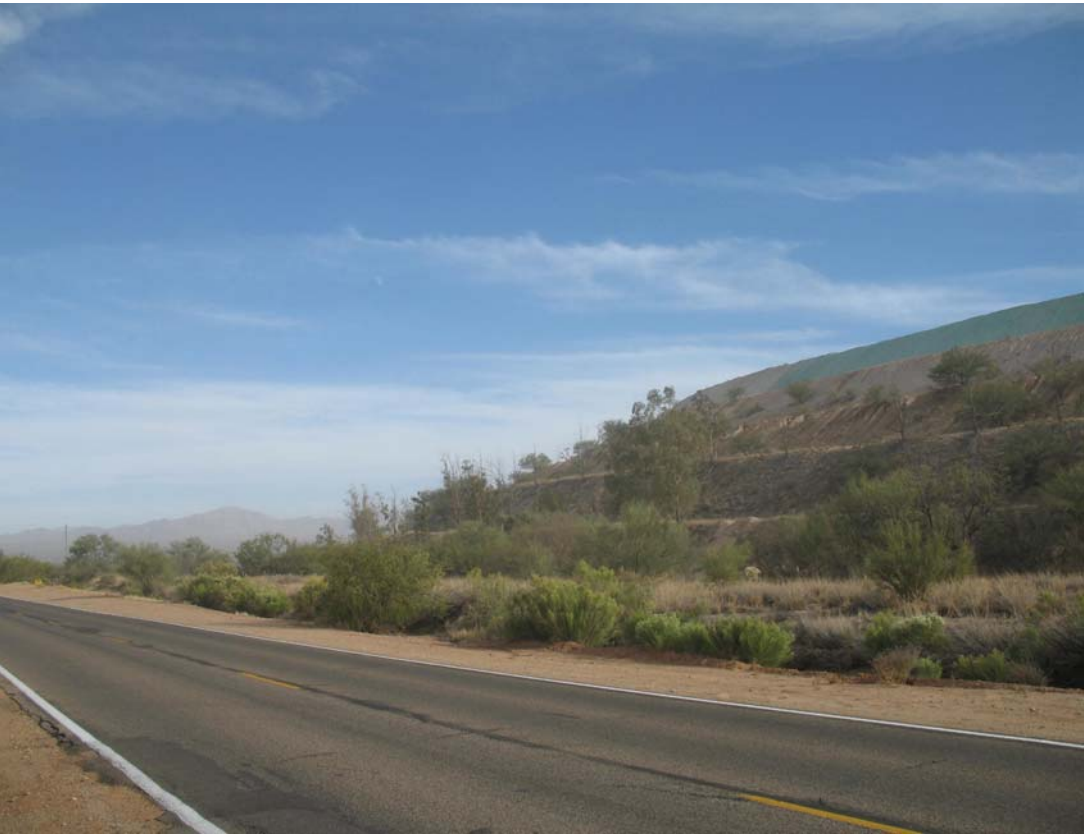
<p>Photo No. 5</p>

The inspector drove west on Helmet Peak Road to get a better vantage looking east that would provide an acceptable angle to perform a VE. The inspector observed that the sun was at an acceptable angle for a VE, but not ideal for the observation of emissions over the east slope of the tailings dam (Attachment 1, Photo 5). The inspector measured the windspeed to be 7 mph average, 16mph maximum, and direction from the southwest at the time of the observation. The inspector performed a VE (Attachment 2). The opacity was measured to be 0.6% between 3:21 pm and 3:27 pm at the time of the observation.

<p>Date: 10/27/2009</p>	
<p>Photo Description:</p> <p>View of northeast corner of tailings dam #8 looking southeast on Helmet Peak Road at 3:22 pm. A Method 9 VE reading was taken from this location (see Attachment #2).</p> <p>The windspeed was measured to be 7 mph average and 16mph maximum with a direction from the southwest at the time of the observation.</p>

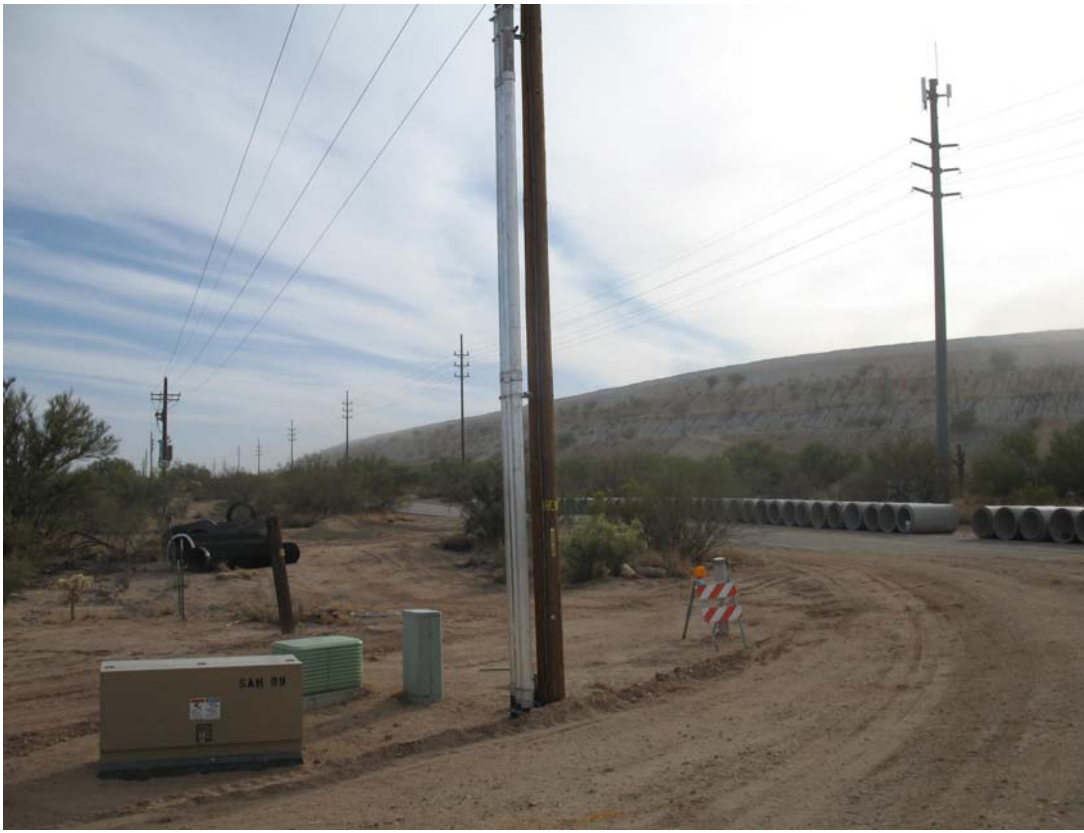
<p>Photo No. 6</p>

<p>Date: 10/27/2009</p>	
<p>Photo Description:</p> <p>View of northeast corner of tailings dam #8 looking south at 3:38 pm.</p>

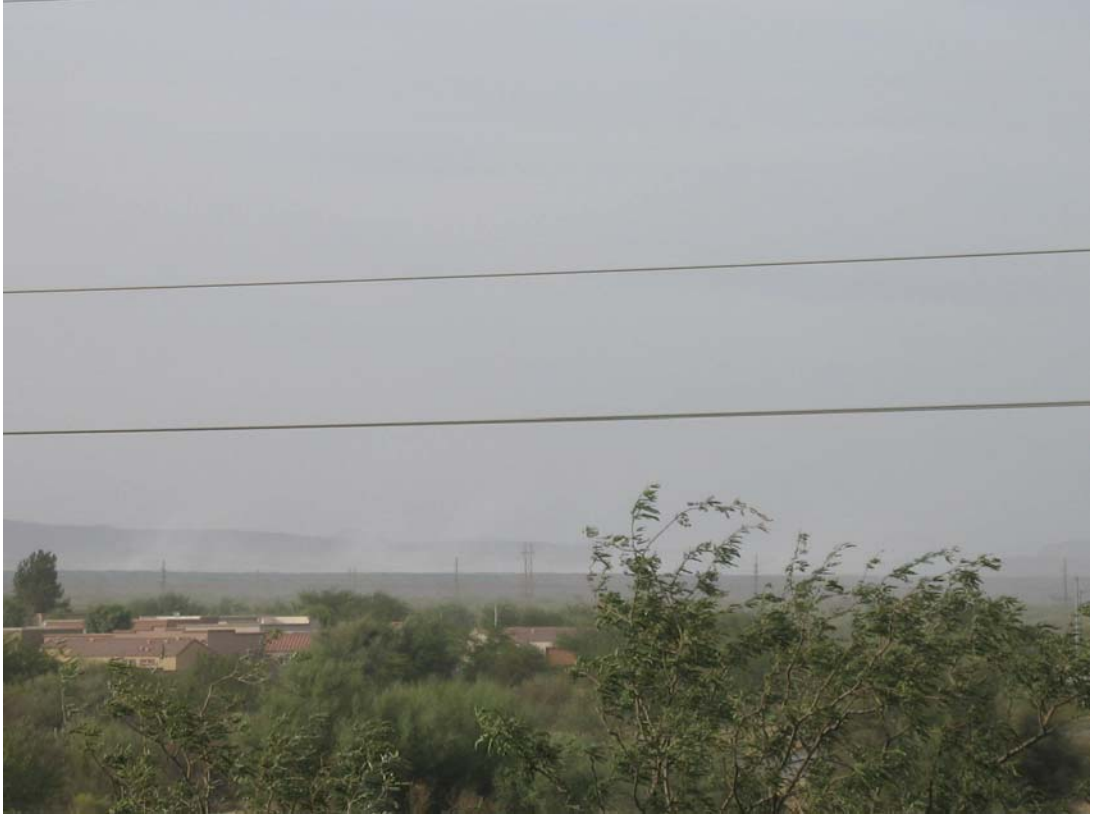
<p>Photo No. 7</p>

<p>Date: 10/27/2009</p>	
<p>Photo Description:</p> <p>View of fugitive particulate matter plume observed at 3:41 pm from the Sahuarita Road/ I-19 overpass looking northwest. The plume is north of tailings dam #8.</p>

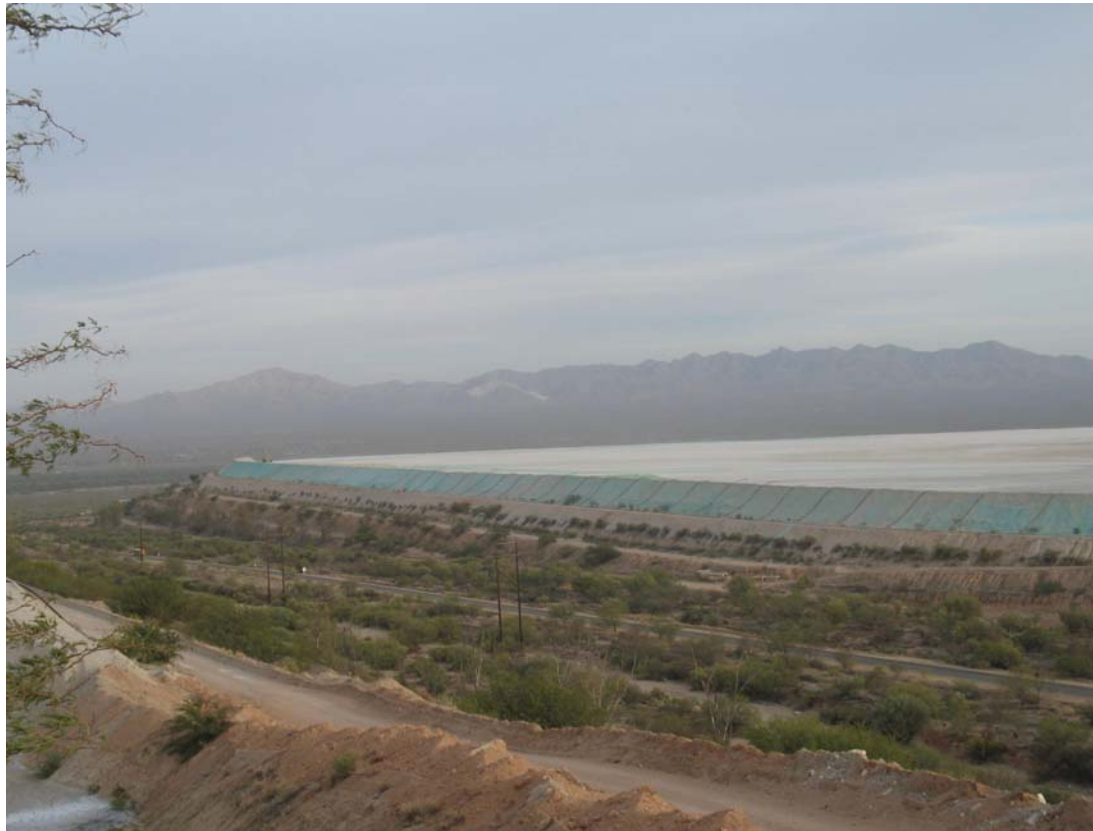
<p>Photo No. 8</p>

<p>Date: 10/27/2009</p>	
<p>Photo Description:</p> <p>View of the northeast corner of the top of tailings impoundment #8 from the southeast corner of tailings impoundment #6 (Point T-5 of Visual Observation Plan) at 4:56 pm.</p> <p>Windspeed was measured to be 18 mph average, 24 mph maximum at the time of the observation with direction from the southwest.</p> <p>No fugitive emissions were observed at the time of the observation.</p>

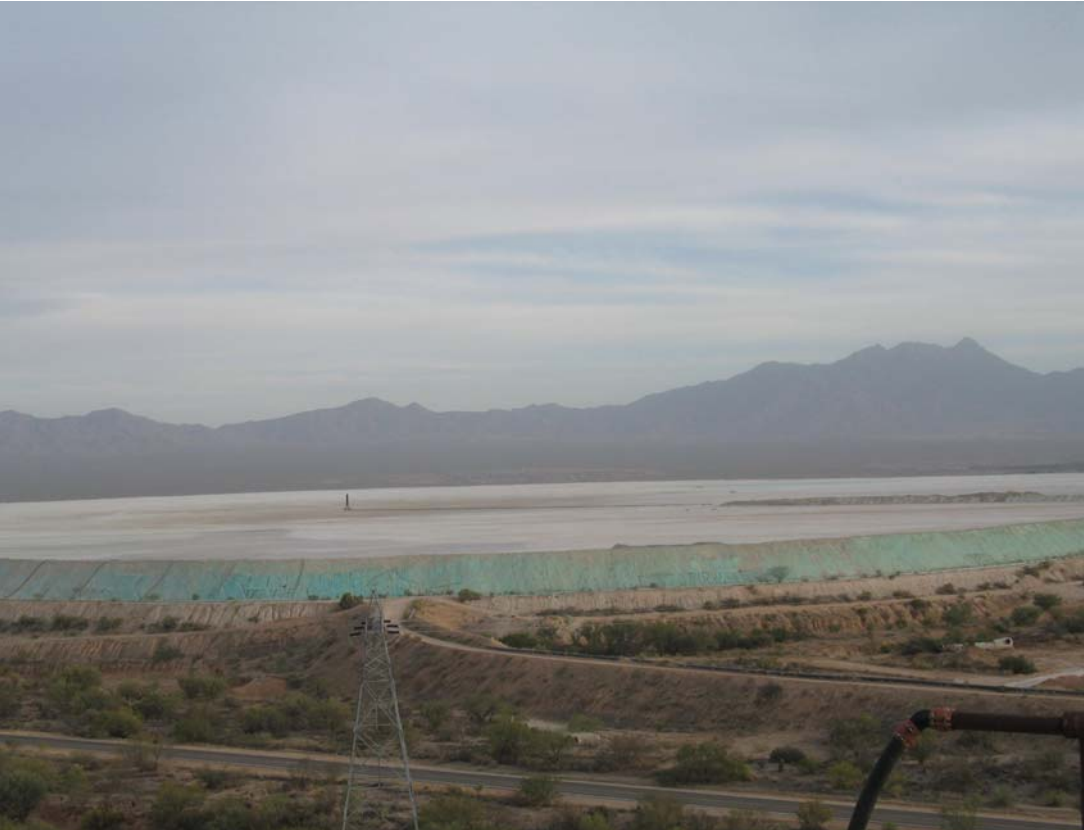
<p>Photo No. 9</p>

<p>Date: 10/27/2009</p>	
<p>Photo Description:</p> <p>View of the central area of the top of tailings impoundment #8 from the southeast corner of tailings impoundment #6 (Point T-5 of Visual Observation Plan) at 4:54 pm.</p> <p>Windspeed was measured to be 18 mph average, 24 mph maximum at the time of the observation with direction from the southwest.</p> <p>No fugitive emissions were observed at the time of the observation.</p>
