**PIMA DEPARTMENT OF ENVIRONMENTAL QUALITY
AIR PROGRAM**

OPPORTUNITY TO CORRECT - TRACKING # 0910-122

December 4, 2009

Complaint Investigation Report

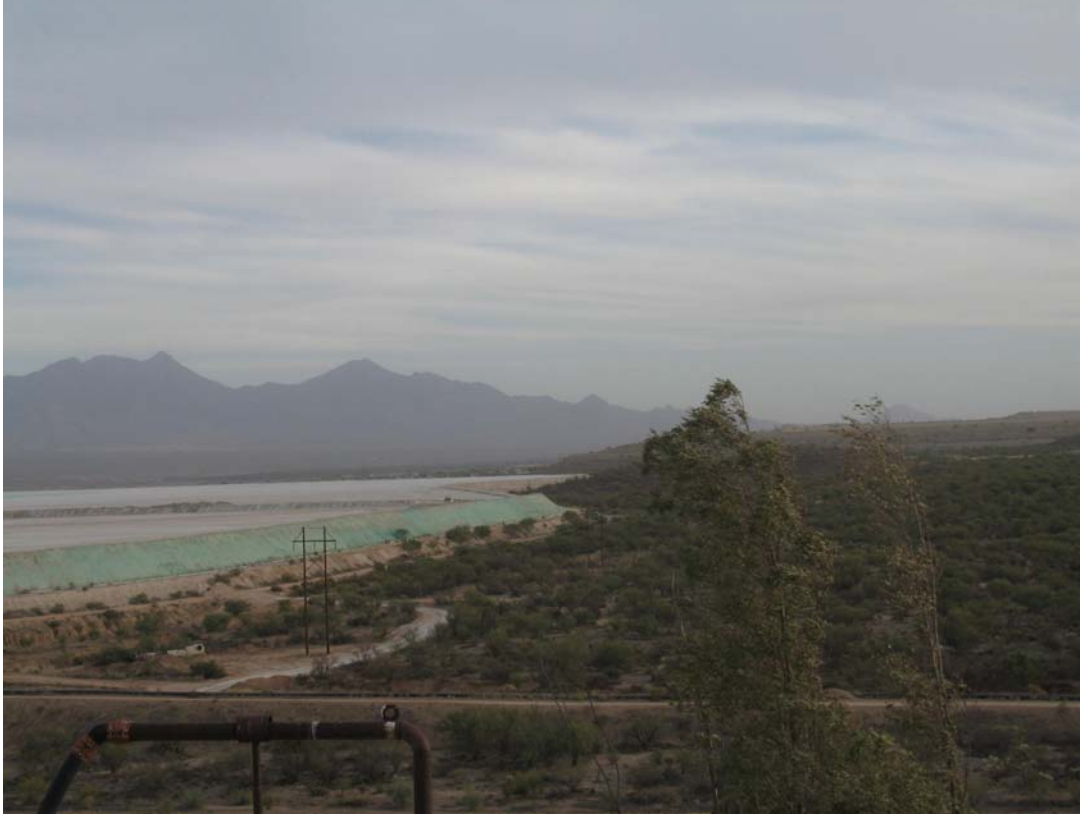
<p>Photo No. 10</p>

<p>Date: 10/27/2009</p>	
<p>Photo Description:</p> <p>View of the south west area of the top of tailings impoundment #8 from the southeast corner of tailings impoundment #6 (Point T-5 of Visual Observation Plan) at 4:54 pm.</p> <p>Windspeed was measured to be 18 mph average, 24 mph maximum at the time of the observation with direction from the southwest.</p> <p>No fugitive emissions were observed at the time of the observation.</p>

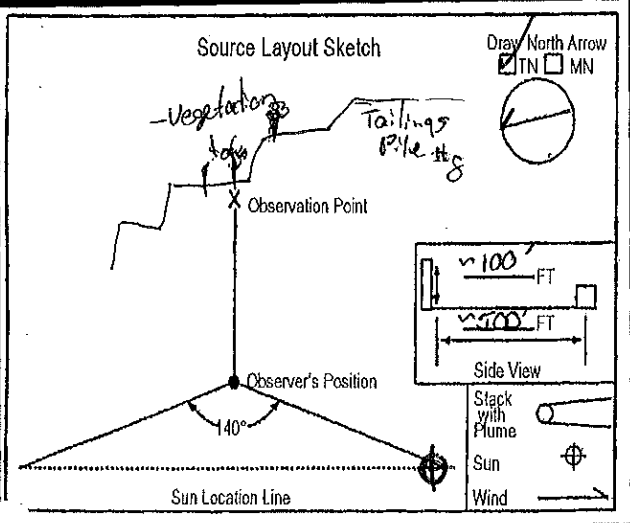
MIN	SEC				COMMENTS
	0	15	30	45	
1	0	10	0	0	
2	0	0	0	0	
3	0	0	0	5	
4	0	0	0	0	
5	0	0	0	0	
6	0	0	0	0	
7	0				Opacity = 0.6
8					AVG-
9					Note:
10					See attached photos
11					taken before + after
12					
13					
14					
15					
16					
17					
18					
19					
20					
21					
22					
23					
24					
25					
26					
27					
28					
29					
30

ADDITIONAL INFORMATION
① Berm building mode - activity suspended due to forecast of high winds.

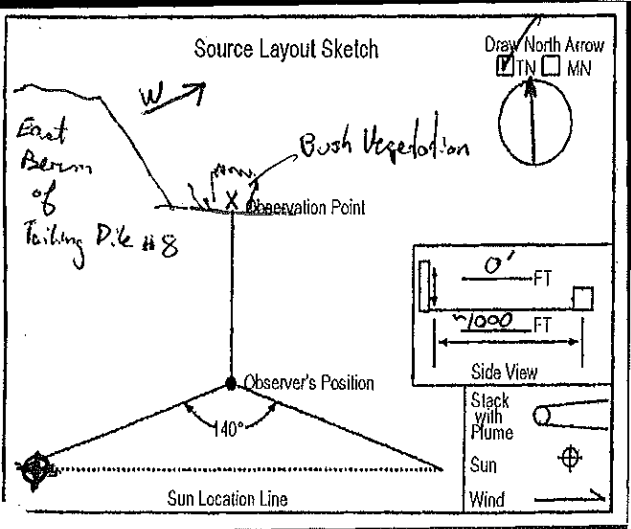
inner impoundment surface area were observed by the inspector as they crossed the east slope of the dam. The opacity was measured to be an average 29.8 % between 5:24 and 5:31 pm (Attachment 4).

MIN	SEC	0	15	30	45	COMMENTS
1	10	10	5	0		Readings taken
2	0	0	20	20		sitting due to wind pressure
3	40	30	20	10		
4	30	40	40	100		winds gusting
5	100	100	100	50		
6	20	0	0	0		
7	0					Opacity
8						Aug = 29.8%
9						
10						
11						See Attached Photos.
12						taken before, during, & after VE evaluation
13						
14						
15						
16						
17						
18						
19						
20						
21						
22						
23						
24						
25						
26						
27						
28						
29						
30
