**PIMA DEPARTMENT OF ENVIRONMENTAL QUALITY
AIR PROGRAM**

Complaint Investigation Report

Tracking ID: PC0912-067

Source: ASARCO, LLC - Mission Complex

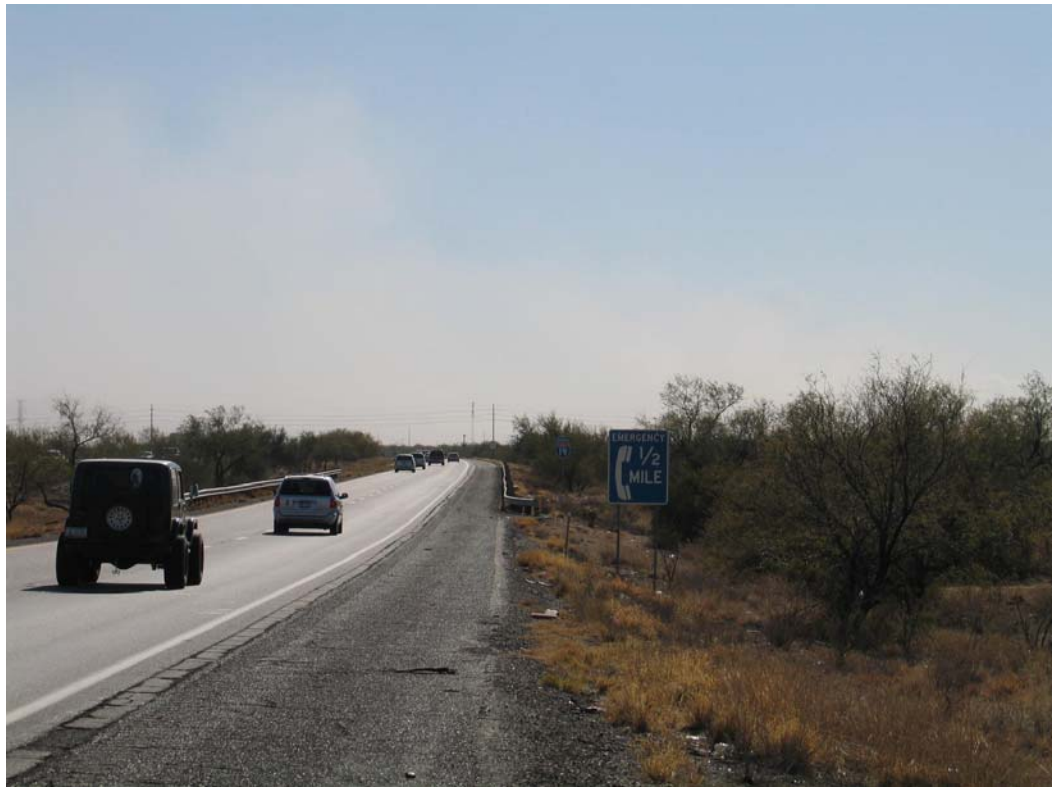
Photo No. 1

View of the light colored visible particulate emissions generating from tailings dam #8 on ASARCO, LLC – Mission Complex property observed crossing I-19 as the inspectors drove southward on I-19 toward Sahuarita Road at 1:00 pm.

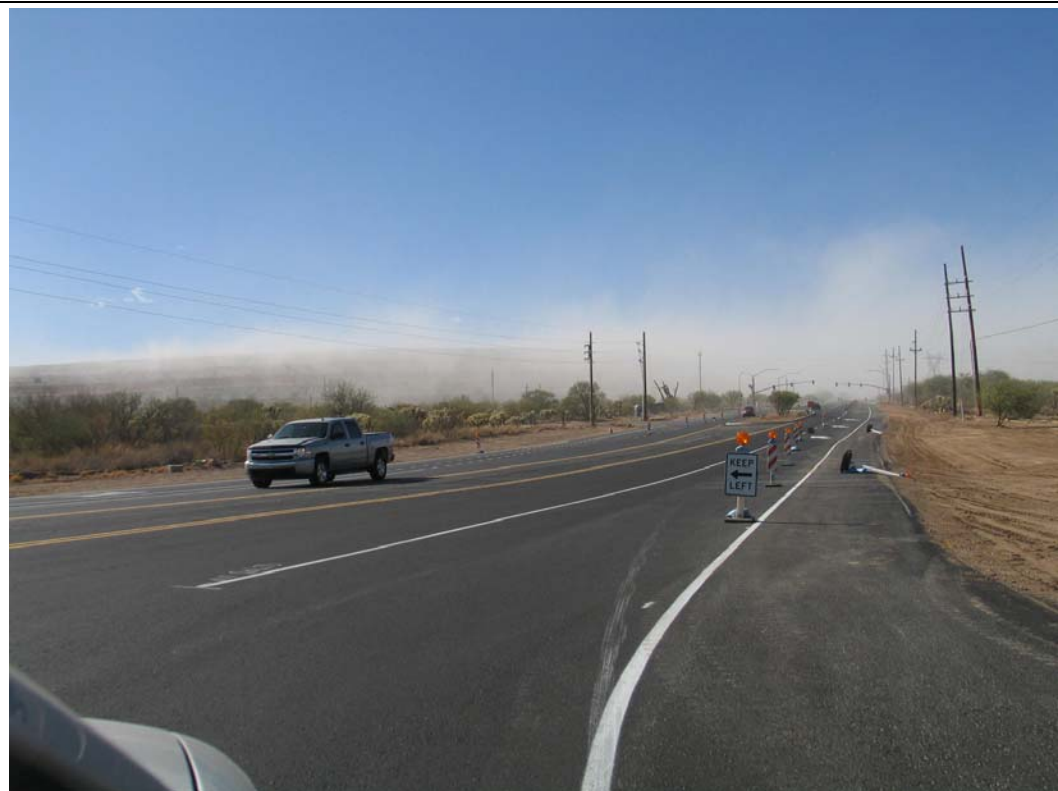
Photo No. 2

At 12:50 pm the inspector measured the windspeed and recorded a 13.1 mph average with a 21 mph maximum at 12:50 pm at the Pima Mine Road exit off of I-19. The inspector drove southward on I-19 toward the Sahuarita Road exit and observed a large particulate emission plume diffusing generating from tailings dam #8 blown in a northeast direction across I-19 (Attachment 1, Photo No. 1). The emission point of the plume was observed to be the northeast corner of tailings dam #8. The inspector proceeded to the Sahuarita Road exit off of I-19 and drove to the east side of tailings dam #8 on La Canada Drive to begin observations and an off-site inspection of the emissions from the tailings dam. The inspector pulled off of Sahuarita Road west of I-19 and observed light colored particulate emissions generating from tailings dam #8 blowing across Helmet Peak Road near the intersection of La Canada Drive and obscuring visibility across the roadway (Attachment 1, Photo No. 2)

View of the light colored visible particulate emissions generating from tailings dam #8 at 1:05 pm as viewed from the side of Sahuarita Road west of I-19. The visible emissions can be observed blowing across Helmet Peak Road and obscuring visibility.

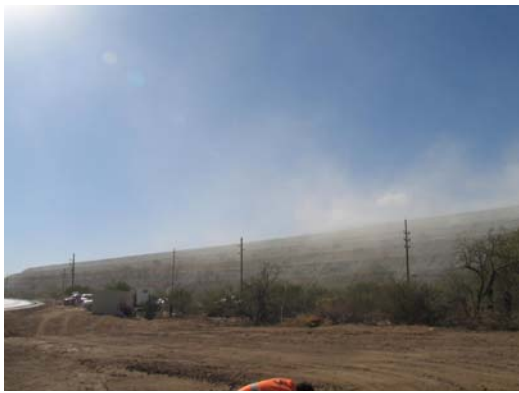
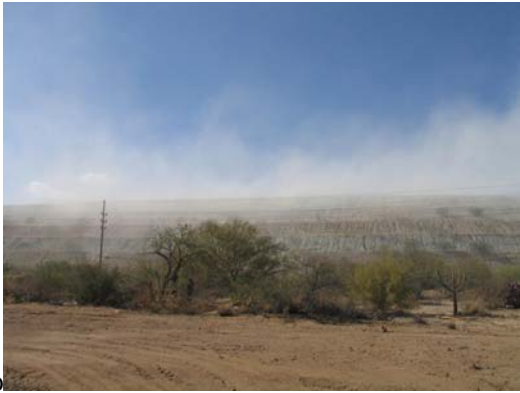
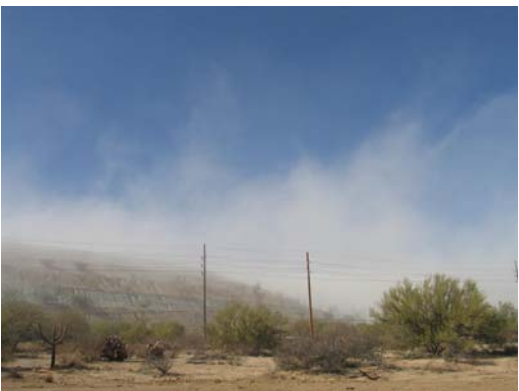
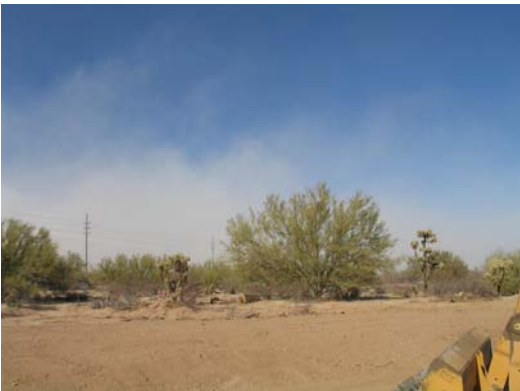
<p>Photo No. 3 a,b,c,d</p>

<p>Photo Description:</p> <p>View of visible particulate emissions generating from tailings dam #8 blowing northeast as viewed from La Canada Drive at 1:10 pm.</p>	<p>a</p>	<p>b</p>

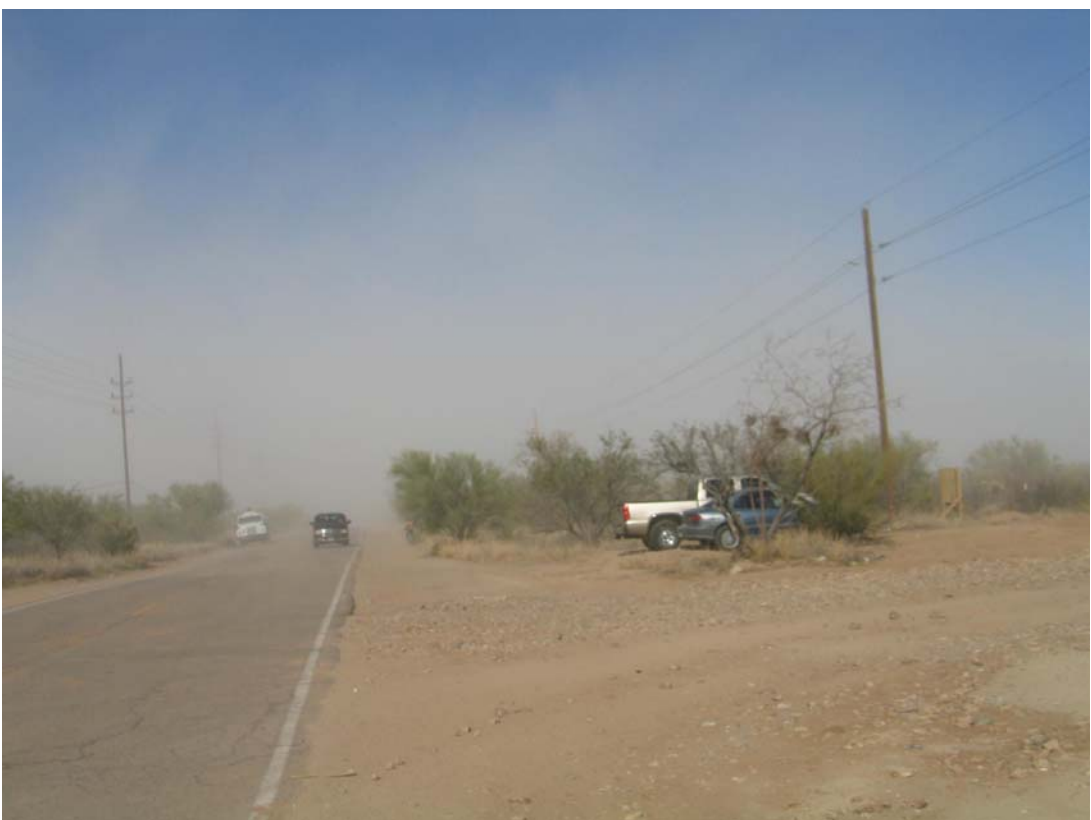
<p>Photo No. 4</p>

<p>Date: 11/22/2009</p>	
<p>Photo Description:</p> <p>View visible particulate emissions plume generating from tailings dam #8 crossing the east property line at La Canada Drive. The inspector took a VE between 1:15 pm and 1:22 pm using the telephone pole along La Canada Drive as a background and a guide to the east property line of ASARCO, LLC – Mission Complex.</p>

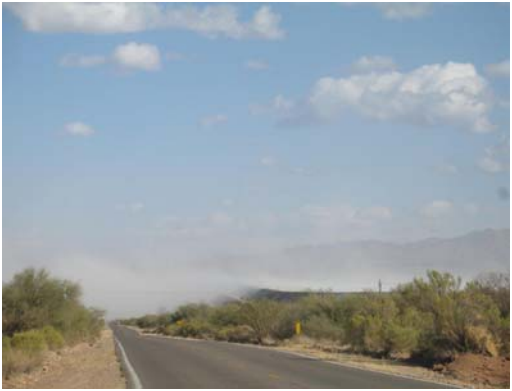
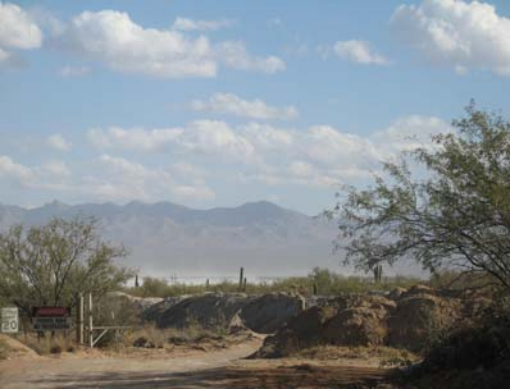
<p>Photo No. 7 a,b</p>	
<p>Date: 11/22/2009</p>	
<p>Photo Description:</p> <p>View of the particulate emission plume generating from top of the tailings dam #8 surface as viewed from west of the tailings dam on Helmet Peak Road looking east at 2:17 pm.</p>	<div style="display: flex; justify-content: space-around;"> <div style="text-align: center;">

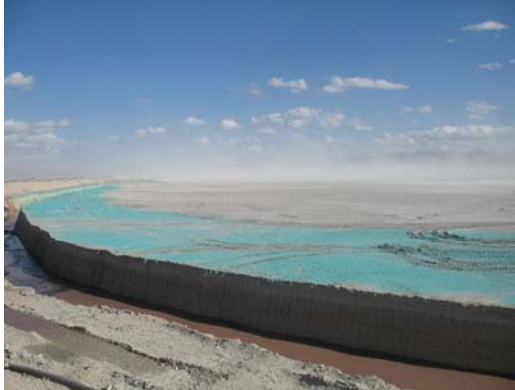
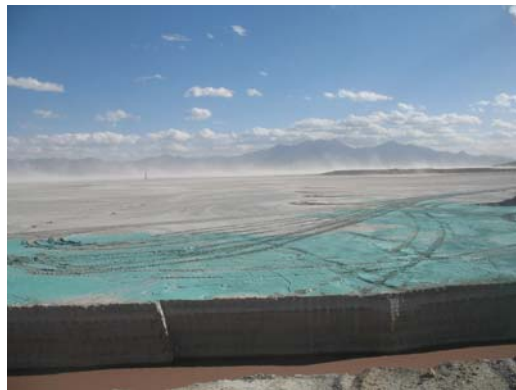
<p>Photo No. 8 a,b</p>	
<p>Date: 11/22/2009</p>	
<p>Photo Description:</p> <p>View of the top of the tailings dam from the top northwest corner showing the particulate emission plume generated from the surface of the tailings dam at 2:32 pm.</p> <p>The trench in the foreground remains from the excavated material used to build the upper lift of top berm around the perimeter of the tailings dam.</p>	<div style="display: flex; justify-content: space-around;"> <div style="text-align: center;">

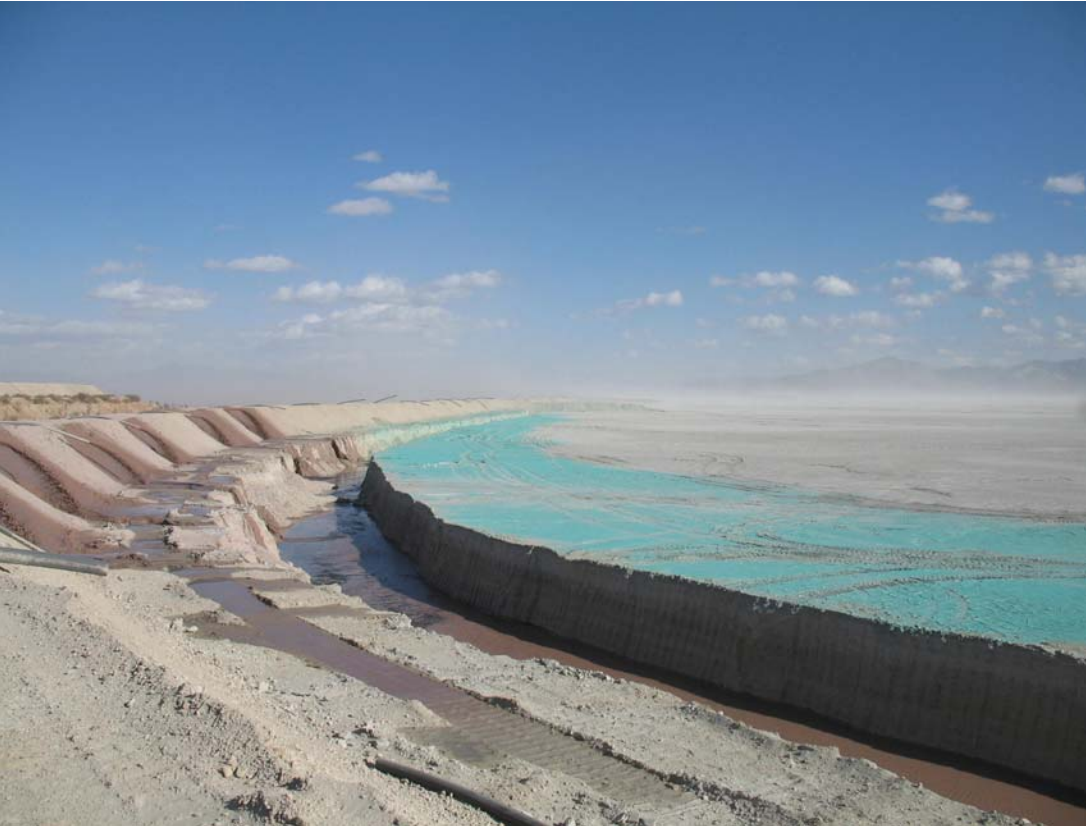
Photo No. 9

The inspector observed pipes placed from the tailings header at the base of the berm over the upper berm at regular intervals around the perimeter along the north slope. Mr. Ekholm indicated they recently began pumping tailings to the fill pipes used to apply the wet tailings slurry to the dam surface. Valves are used to divert the tailings slurry from the header through the pipes. The inspector followed Mr. Ekholm to the top of the dam to view the top surface of the tailings dam. The inspector observed that wet tailings slurry was being pumped and flowing from 6 pipes at the northwest corner and had begun to fill the trench left over from excavating berm material in this section. The inspector inquired why the tailings were not flowing from the other fill pipes around the perimeter. Mr. Ekholm indicated the system only allowed application through a limited number of the pipes at any one time (Attachment 1, Photo No. 9).

ASARCO, LLC – Mission Complex began berm building on tailings dam #8 on September 14, 2009, and as of December 22, 2009, did not monitor to ensure that a light coat of fresh, moist tailings was applied to the surface of the dam.

Date: 11/22/2009	
Photo Description: View of the fill pipes on the right discharging tailings slurry. The trench in the foreground must fill before the tailings can wet and smear the inner dam surface.

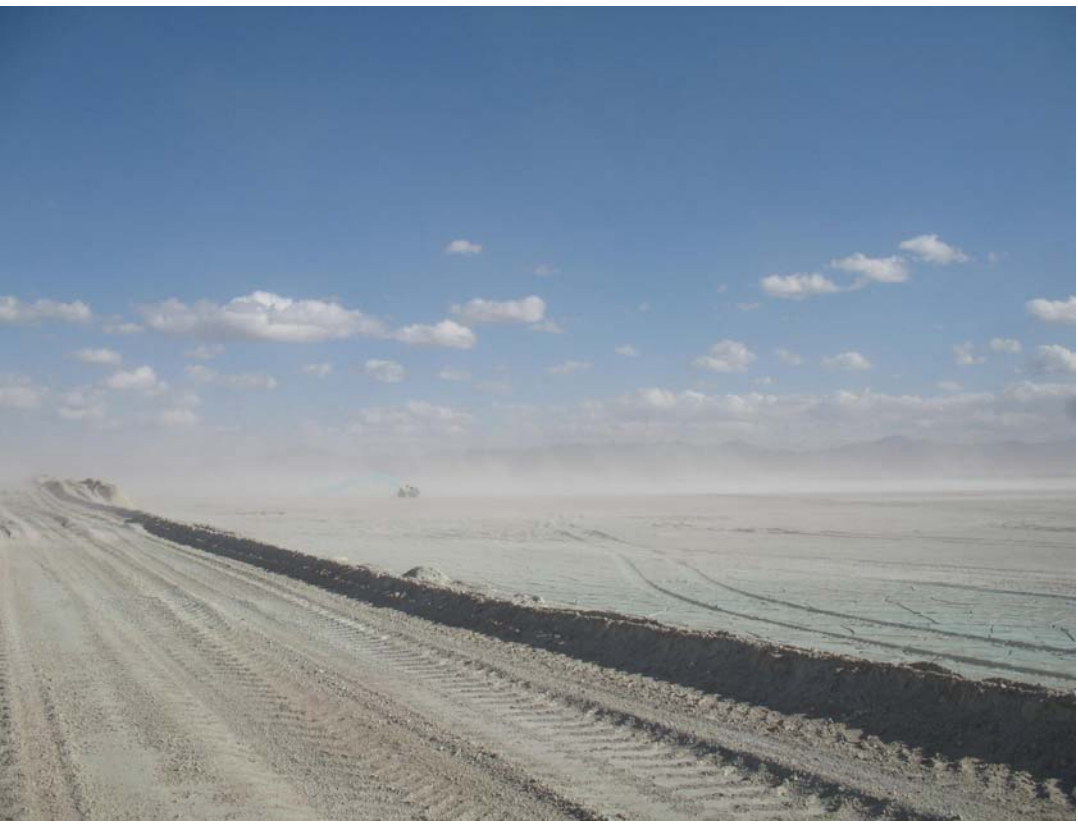
Photo No. 10

Date: 11/22/2009	
Photo Description: View of a truck applying water and polymer on south east quadrant of the tailings dam surface.

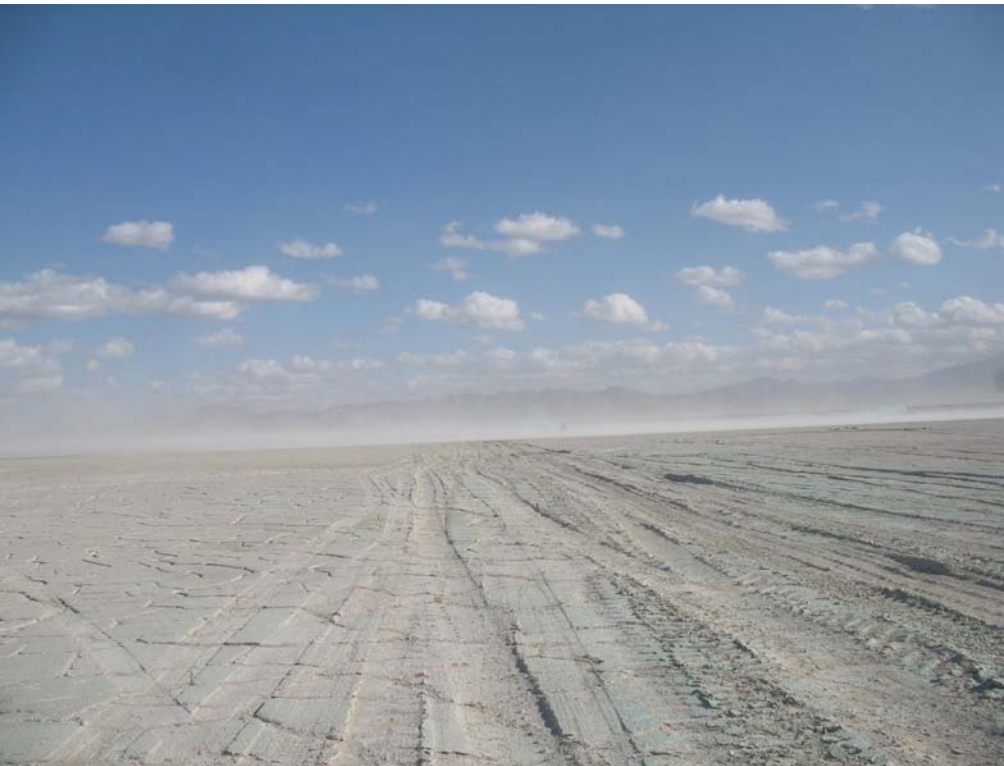
Photo No. 12

The inspector took a VE opacity of the emission plume from the surface of tailings impoundment #8. Between 2:40 pm and 2:47 pm, the average opacity was measured to be 80.4 % at a point approximately 800 feet east of the emission plume on the southeast quadrant of the tailings dam surface (Attachment 5). The windspeed was measured with a Kestrel windspeed meter during the VE and measured 18.6 mph avg., 36 mph max., and 23 mph avg., 45 mph max.

Date: 11/22/2009	
Photo Description: View of the particulate emission plume and view at the end of the VE taken in the southwest quadrant of the tailings surface at 2:47 pm.

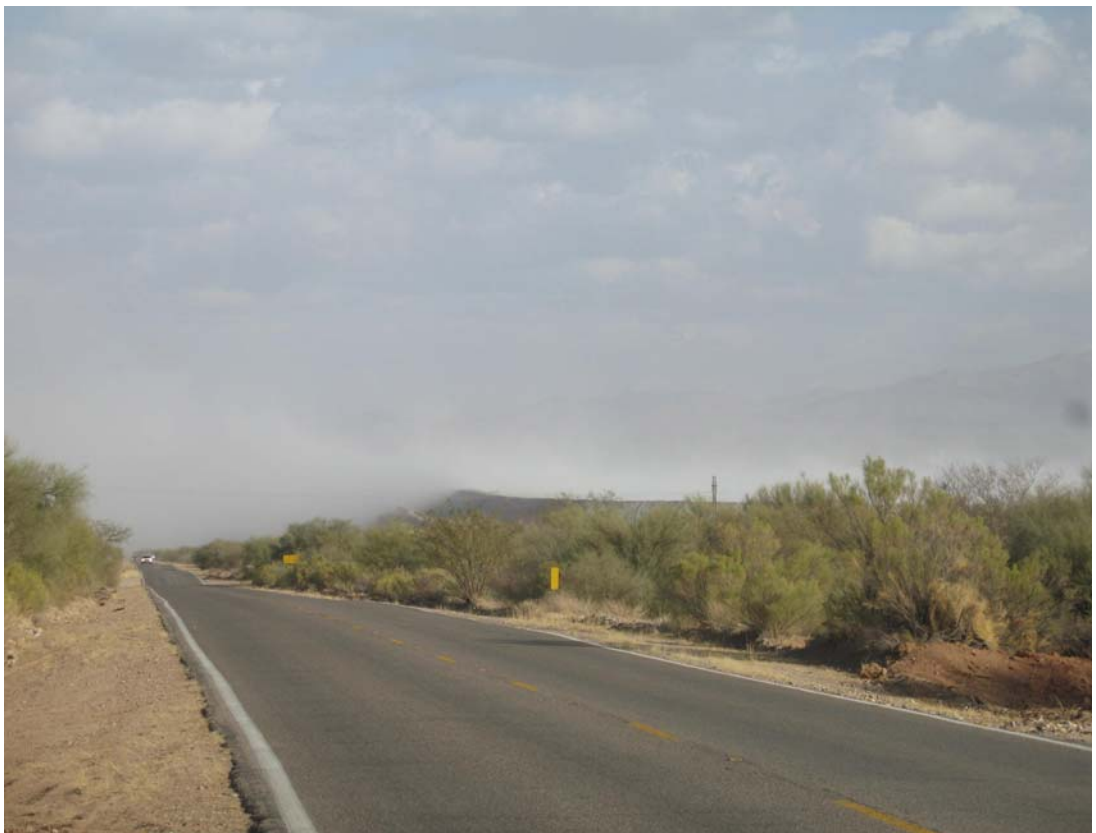
Photo No. 13

View of the particulate emission plume and generating from tailings dam #8 blowing across Helmet Peak Road as the inspector views looking east at 3:21 pm.
