**PIMA DEPARTMENT OF ENVIRONMENTAL QUALITY
AIR PROGRAM**

Complaint Investigation Report

Tracking ID: PC0912-067

Source: ASARCO, LLC - Mission Complex

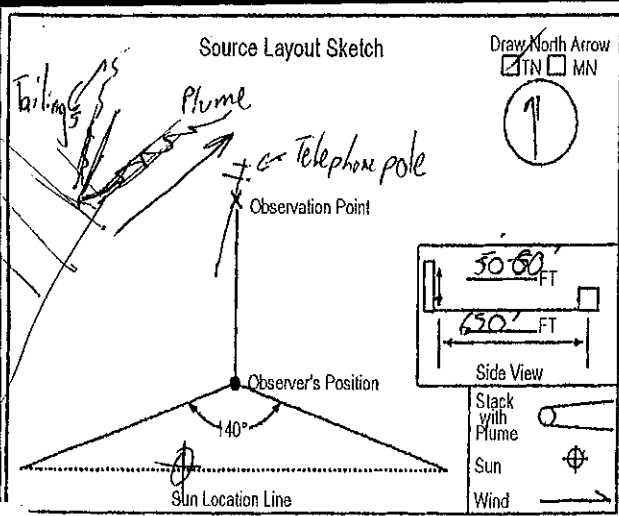
OBSERVATION DATE 12/22/2009	START TIME 13:15 pm	END TIME 13:22 pm
---------------------------------------	-------------------------------	-----------------------------

MIN \ SEC	0	15	30	45	COMMENTS
1	0	5	10	5	
2	10	20	20	5	Observation point
3	5	5	40	40	only catching outer
4	20	15	30	40	fringe of plume
5	20	10	5	10	
6	40	80	40	50	Opacity Avg 23.4%
7	40	15	10		
8					See attached Photos
9					
10					
11					
12					
13					
14					
15					
16					
17					
18					
19					
20					
21					
22					
23					
24					
25					
26					
27					
28					
29					
30

ADDITIONAL INFORMATION
 ① Activity Suspended due to forecast of high winds. Fugitive Dust Control w/ Polymer water trucks

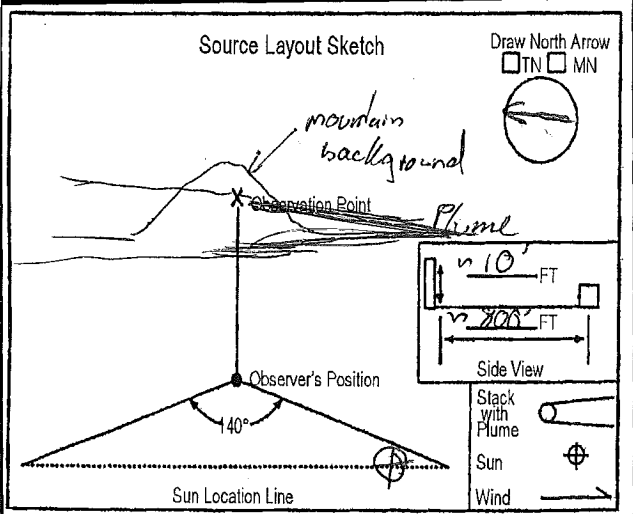
OBSERVATION DATE 12/22/2009	START TIME 2:40 pm	END TIME 2:47 pm
---------------------------------------	------------------------------	----------------------------

MIN	SEC				COMMENTS
	0	15	30	45	
1	100	100	100	40	
2	75	100	60	50	
3	100	100	100	100	
4	100	100	100	100	
5	100	100	40	40	
6	30	70	60	85	
7	60				Opacity Avg. 80.4%
8					
9					(see attached photo)
10					
11					
12					
13					
14					
15					
16					
17					
18					
19					
20					
21					
22					
23					
24					
25					
26					
27					
28					
29					
30

ADDITIONAL INFORMATION
 ① Activity on Tailings Building Suspended due to forecast of high winds. Fugitive Dust Control application of Polymer & Water with Trucks
